Access Compliance Report

Public Rights-of-Way

(Curb Ramps)

Intersection ID: 43685	Main Street: HARLINGTON_LN	Cross Street: TODDINGTON_LN	Location: NW
ADA ID: 1D6B68110FEE	Ramp Type: PerpDiag	Initial Pass/Fail: Fail	Overall Compliance: No
Severity Score: 8.75			
Codes/Mitigation Info/Possible Solution		Field Measurements/Component Compliance

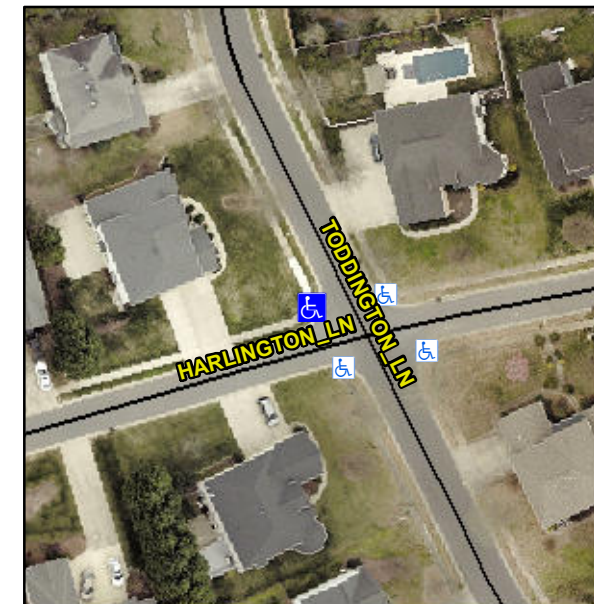
PROW/ADA:

Not Found, R304.5.1

Possible Solutions:

Remove & Replace Curb Ramp With Two New Directional Ramps or Equivalent.

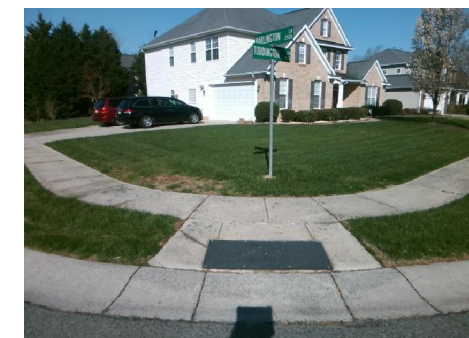
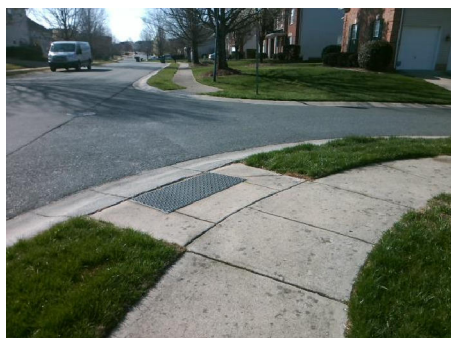
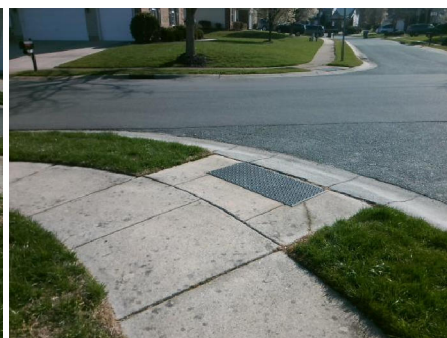
Compliance	Description	Data	Compliance	Description	Data
N/A	Ramp Length (in)	48.0	Yes	Ramp Slope (%)	5.2
No	Ramp Width (in)	39.5	Yes	Ramp XSlope (%)	0.1
N/A	Flare Type LT	N/A	N/A	Flare Type RT	N/A
N/A	Flare Slope LT (%)	N/A	N/A	Flare Slope RT (%)	N/A
N/A	Flare Traversable LT?	N/A	N/A	Flare Traversable RT?	N/A
N/A	Landing Length (in)	N/A	N/A	DWS Provided?	N/A
N/A	Landing Width (in)	N/A	N/A	DWS Contrast?	N/A
N/A	Landing Slope (%)	N/A	N/A	DWS Length (in)	N/A
N/A	Landing X Slope (%)	N/A	N/A	DWS Full Width?	N/A
N/A	Landing Curb? (Y/N)	N/A	N/A	DWS Offset (in)	N/A
N/A	Shared Landing?	N/A			
N/A	Gutter Ponding?	N/A	N/A	Gutter Slope (%)	N/A
N/A	Gutter Lip Ht (in)	N/A	N/A	Gutter X Slope (%)	N/A
N/A	Painted X Walk1?	No	N/A	Painted X Walk2?	No
	X Walk 1 Direction	To S		X Walk 2 Direction	To E
N/A	X Walk 1 Width (in)	N/A	N/A	X Walk 2 Width (in)	N/A
	X Walk 1 Slope (%)	1.3		X Walk 2 Slope (%)	3.2
	X Walk 1 X Slope (%)	1.7		X Walk 2 X Slope (%)	3.3

N/A	Ramp inside XWalk1?	N/A	N/A	Ramp inside XWalk2?	N/A
	Road Slope (%)	0.3	N/A	Clear Space?	N/A
	Road X Slope (%)	3.1	N/A	Clear Space to XWalk (in)	N/A
N/A	Any Obstructions?	N/A	N/A	Storm Grate/Utility Hazard?	N/A
	Obstruction Type			Storm Grate/Utility Type	
		N/A			N/A
		Yes		Surface Condition? (G/P)	Good
