Access Compliance Report

Public Rights-of-Way

(Curb Ramps)

Intersection ID: 10970	Main Street: FRAZIER_AV	Cross Street: MONTGOMERY_ST	Location:	N
ADA ID: 1D78732E71A3	Ramp Type: PerpDiag	Initial Pass/Fail: Fail	Overall Compliance: No	Severity Score: 36.25
Codes/Mitigation Info/Possible Solution		Field Measurements/Component Compliance

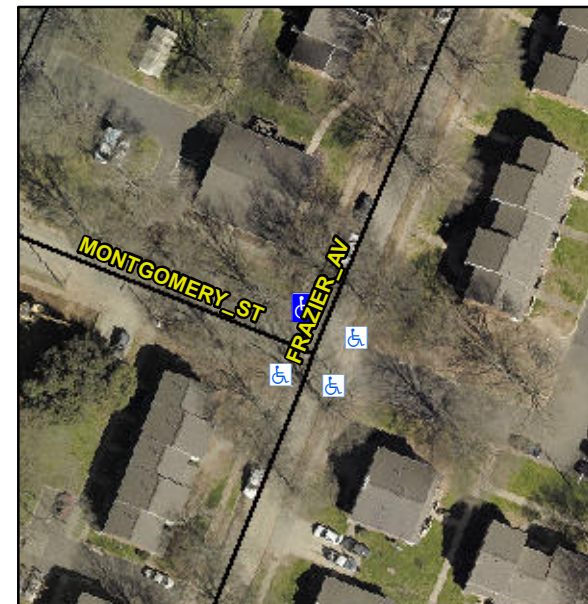
Not Found, R304.5.1, R304.5.3

Compliance	Description	Data	Compliance	Description	Data
N/A	Ramp Length (in)	46.0	Yes	Ramp Slope (%)	5.3
No	Ramp Width (in)	27.0	No	Ramp XSlope (%)	2.5
N/A	Flare Type LT	N/A	N/A	Flare Type RT	N/A
N/A	Flare Slope LT (%)	N/A	N/A	Flare Slope RT (%)	N/A
N/A	Flare Traversable LT?	N/A	N/A	Flare Traversable RT?	N/A
N/A	Landing Length (in)	N/A	N/A	DWS Provided?	N/A
N/A	Landing Width (in)	N/A	N/A	DWS Contrast?	N/A
N/A	Landing Slope (%)	N/A	N/A	DWS Length (in)	N/A
N/A	Landing X Slope (%)	N/A	N/A	DWS Full Width?	N/A
N/A	Landing Curb? (Y/N)	N/A	N/A	DWS Offset (in)	N/A
N/A	Shared Landing?	N/A			
N/A	Gutter Ponding?	N/A	N/A	Gutter Slope (%)	N/A
N/A	Gutter Lip Ht (in)	1.5	N/A	Gutter X Slope (%)	N/A
N/A	Painted X Walk1?	No	N/A	Painted X Walk2?	No
	X Walk 1 Direction	To SW		X Walk 2 Direction	To SE
N/A	X Walk 1 Width (in)	N/A	N/A	X Walk 2 Width (in)	N/A
	X Walk 1 Slope (%)	0.8		X Walk 2 Slope (%)	2.5
	X Walk 1 X Slope (%)	3.3		X Walk 2 X Slope (%)	2.6

N/A	Ramp inside XWalk1?	N/A	N/A	Ramp inside XWalk2?	N/A
	Road Slope (%)	0.7	N/A	Clear Space?	N/A
	Road X Slope (%)	2.8	N/A	Clear Space to XWalk (in)	N/A
N/A	Any Obstructions?	N/A	N/A	Storm Grate/Utility Hazard?	N/A
	Obstruction Type			Storm Grate/Utility Type	
		N/A			N/A
			Yes	Surface Condition? (G/P)	Good

Remove & Replace Curb Ramp With Two New Directional Ramps or Equivalent.
