Access Compliance Report

Public Rights-of-Way

(Curb Ramps)

Intersection ID: N/A	Main Street: W_W_T_HARRIS_BVLD	Cross Street: N/A	Location: SE
ADA ID: 1D7EE9146860	Ramp Type: Perp	Initial Pass/Fail: Fail	Overall Compliance: No
Severity Score: 1.25			
Codes/Mitigation Info/Possible Solution		Field Measurements/Component Compliance

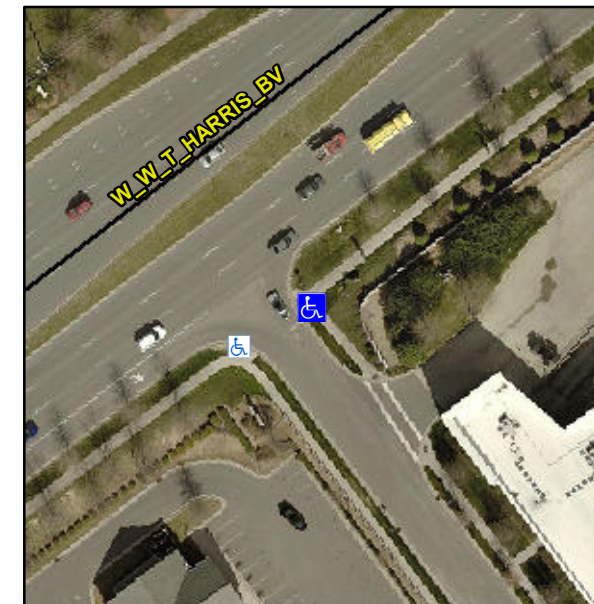
Not Found, R304.5.3

Compliance	Description	Data	Compliance	Description	Data
N/A	Ramp Length (in)	98.0	Yes	Ramp Slope (%)	7.8
Yes	Ramp Width (in)	48.0	No	Ramp XSlope (%)	2.8
N/A	Flare Type LT	N/A	N/A	Flare Type RT	N/A
N/A	Flare Slope LT (%)	N/A	N/A	Flare Slope RT (%)	N/A
N/A	Flare Traversable LT?	No	N/A	Flare Traversable RT?	No
N/A	Landing Length (in)	N/A	N/A	DWS Provided?	N/A
N/A	Landing Width (in)	N/A	N/A	DWS Contrast?	N/A
N/A	Landing Slope (%)	N/A	N/A	DWS Length (in)	N/A
N/A	Landing X Slope (%)	N/A	N/A	DWS Full Width?	N/A
N/A	Landing Curb? (Y/N)	N/A	N/A	DWS Offset (in)	N/A
N/A	Shared Landing?	N/A			
N/A	Gutter Ponding?	N/A	N/A	Gutter Slope (%)	N/A
N/A	Gutter Lip Ht (in)	N/A	N/A	Gutter X Slope (%)	N/A
N/A	Painted X Walk1?	No	N/A	Painted X Walk2?	N/A
	X Walk 1 Direction	To W		X Walk 2 Direction	N/A
N/A	X Walk 1 Width (in)	N/A	N/A	X Walk 2 Width (in)	N/A
	X Walk 1 Slope (%)	7.7		X Walk 2 Slope (%)	N/A
	X Walk 1 X Slope (%)	1.1		X Walk 2 X Slope (%)	N/A

N/A	Ramp inside XWalk1?	N/A	N/A	Ramp inside XWalk2?	N/A
	Road Slope (%)	N/A	N/A	Clear Space?	N/A
	Road X Slope (%)	N/A	N/A	Clear Space to XWalk (in)	N/A
N/A	Any Obstructions?	N/A	N/A	Storm Grate/Utility Hazard?	N/A
	Obstruction Type			Storm Grate/Utility Type	
		N/A			N/A
		Yes		Surface Condition? (G/P)	Good

Remove & Replace Entire Ramp.

Total Cost: \$ 1850.00
