Access Compliance Report

Public Rights-of-Way

(Curb Ramps)

Intersection ID: 16140	Main Street: CEDARWOOD_LN	Cross Street: FARMINGDALE_DR	Location: NE
ADA ID: 1D821B8591D3	Ramp Type: PerpDiag	Initial Pass/Fail: Fail	Overall Compliance: No
Severity Score: 21.25			
Codes/Mitigation Info/Possible Solution		Field Measurements/Component Compliance

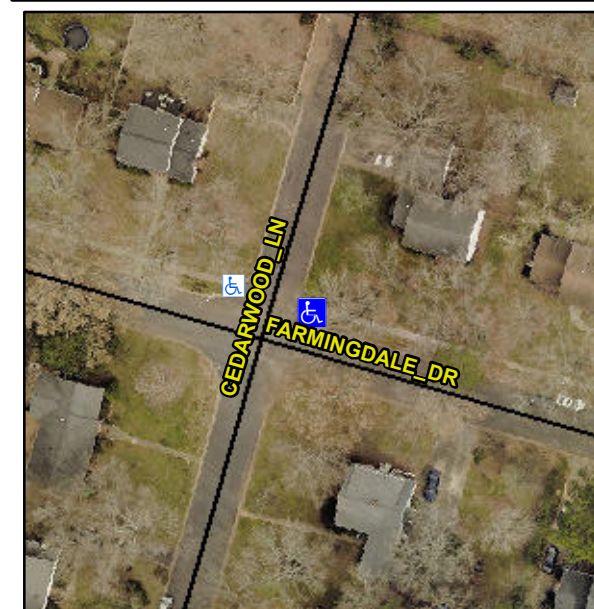
Not Found, R304.5.1, R304.2.2

Compliance	Description	Data	Compliance	Description	Data
N/A	Ramp Length (in)	33.0	No	Ramp Slope (%)	8.9
No	Ramp Width (in)	43.0	Yes	Ramp XSlope (%)	1.2
N/A	Flare Type LT	N/A	N/A	Flare Type RT	N/A
N/A	Flare Slope LT (%)	N/A	N/A	Flare Slope RT (%)	N/A
N/A	Flare Traversable LT?	N/A	N/A	Flare Traversable RT?	N/A
N/A	Landing Length (in)	N/A	N/A	DWS Provided?	N/A
N/A	Landing Width (in)	N/A	N/A	DWS Contrast?	N/A
N/A	Landing Slope (%)	N/A	N/A	DWS Length (in)	N/A
N/A	Landing X Slope (%)	N/A	N/A	DWS Full Width?	N/A
N/A	Landing Curb? (Y/N)	N/A	N/A	DWS Offset (in)	N/A
N/A	Shared Landing?	N/A			
N/A	Gutter Ponding?	N/A	N/A	Gutter Slope (%)	N/A
N/A	Gutter Lip Ht (in)	N/A	N/A	Gutter X Slope (%)	N/A
N/A	Painted X Walk1?	No	N/A	Painted X Walk2?	No
	X Walk 1 Direction	To NW		X Walk 2 Direction	To SW
N/A	X Walk 1 Width (in)	N/A	N/A	X Walk 2 Width (in)	N/A
	X Walk 1 Slope (%)	1.1		X Walk 2 Slope (%)	1.1
	X Walk 1 X Slope (%)	2.7		X Walk 2 X Slope (%)	2.4

N/A	Ramp inside XWalk1?	N/A	N/A	Ramp inside XWalk2?	N/A
	Road Slope (%)	2.6	N/A	Clear Space?	N/A
	Road X Slope (%)	1.2	N/A	Clear Space to XWalk (in)	N/A
N/A	Any Obstructions?	N/A	N/A	Storm Grate/Utility Hazard?	N/A
	Obstruction Type			Storm Grate/Utility Type	
		N/A			N/A
		Yes		Surface Condition? (G/P)	Good

Remove & Replace Curb Ramp With Two New Directional Ramps or Equivalent.

Total Cost: \$ 3200.00
