Access Compliance Report

Public Rights-of-Way

(Curb Ramps)

Intersection ID: 44935	Main Street: NATHAN_DR	Cross Street: REEDMONT_LN	Location: SE
ADA ID: 1D84A35A88E1	Ramp Type: PerpDiag	Initial Pass/Fail: Pass	Overall Compliance: No
		Severity Score: 0

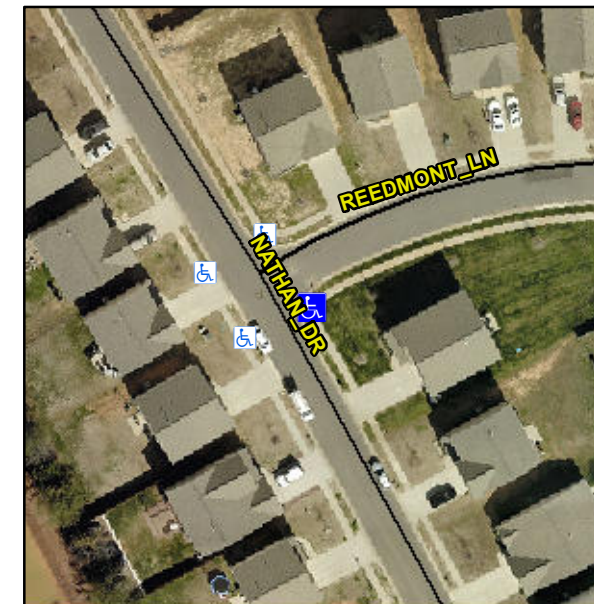
Compliance	Description	Data	Compliance	Description	Data
N/A	Ramp Length (in)	47.5	Yes	Ramp Slope (%)	5.8
Yes	Ramp Width (in)	48.0	Yes	Ramp XSlope (%)	1.6
N/A	Flare Type LT	Sloped	N/A	Flare Type RT	N/A
N/A	Flare Slope LT (%)	2.7	N/A	Flare Slope RT (%)	9.2
N/A	Flare Traversable LT?	No	N/A	Flare Traversable RT?	No
Yes	Landing Length (in)	48.5	Yes	DWS Provided?	Yes
Yes	Landing Width (in)	48.0	Yes	DWS Contrast?	Yes
Yes	Landing Slope (%)	0.9	Yes	DWS Length (in)	24.0
Yes	Landing X Slope (%)	1.0	Yes	DWS Full Width?	Yes
N/A	Landing Curb? (Y/N)	No	No	DWS Offset (in)	3.5
N/A	Shared Landing?	No			
Yes	Gutter Ponding?	No	Yes	Gutter Slope (%)	0.4
Yes	Gutter Lip Ht (in)	0.0	No	Gutter X Slope (%)	2.3
N/A	Painted X Walk1?	No	N/A	Painted X Walk2?	No
	X Walk 1 Direction	To N		X Walk 2 Direction	To W
N/A	X Walk 1 Width (in)	N/A	N/A	X Walk 2 Width (in)	N/A
	X Walk 1 Slope (%)	2.2		X Walk 2 Slope (%)	1.3
	X Walk 1 X Slope (%)	0.8		X Walk 2 X Slope (%)	3.6

N/A	Ramp inside XWalk1?	N/A	N/A	Ramp inside XWalk2?	N/A
	Road Slope (%)	1.8	N/A	Clear Space?	Yes
	Road X Slope (%)	2.3	N/A	Clear Space to XWalk (in)	N/A
Yes	Any Obstructions?	No	Yes	Storm Grate/Utility Hazard?	No
	Obstruction Type			Storm Grate/Utility Type	
		N/A			N/A
			Yes	Surface Condition? (G/P)	Good

Possible Solutions:

Remove & Replace Detectable Warning System. Remove & Replace Gutter.

R305.2, R304.5.3
