# Access Compliance Report

## Public Rights-of-Way

### (Curb Ramps)

| Intersection ID: 45096 | Main Street: E_9TH_ST | Cross Street: N_DAVIDSON_ST | Location: N |

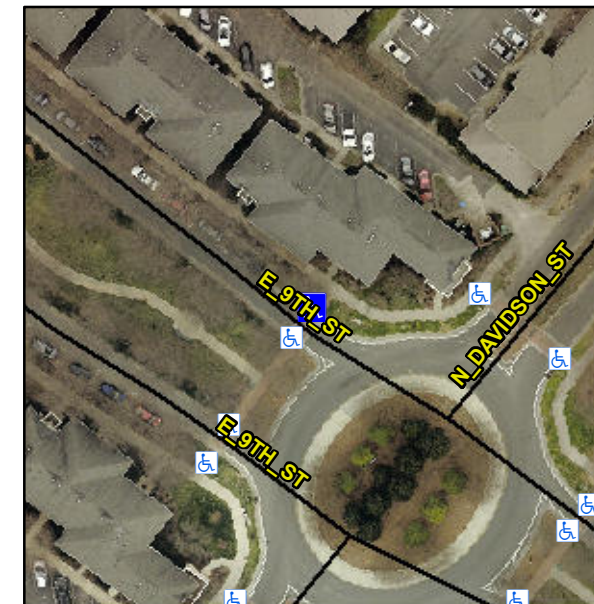
PROW/ADA:

**Not Found, R302.7**

| Compliance | Description | Data | Compliance | Description | Data |
|---|---|---|---|---|---|
| No | Gutter Ponding? | Yes | Yes | Gutter Slope (%) | 1.2 |

Possible Solutions:

**Remove & Replace Entire Ramp.**

Total Cost: \$ 1850.00
