# Access Compliance Report

## Public Rights-of-Way

### (Curb Ramps)

| Intersection ID: N/A | Main Street: POTOMAC_RIVER_PY | Cross Street: NATIONAL_AV | Location: NE |

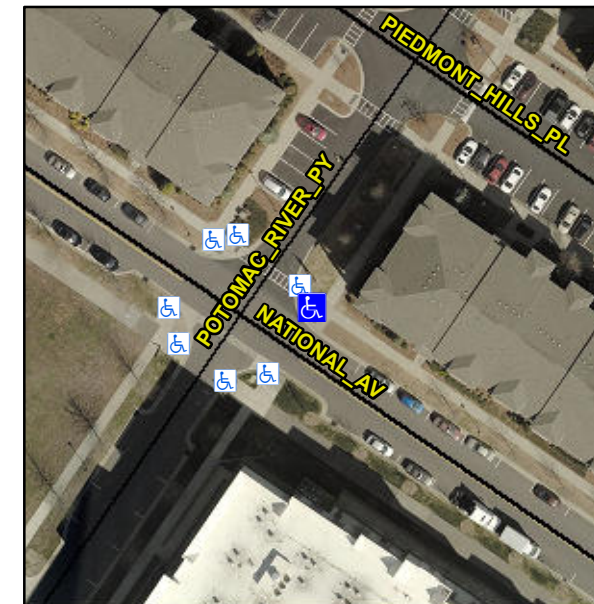
**R304.2.2-Perp, R304.3.2-Para,  
R304.2.3, R305.1.4, R305.2, R304.5.4**

| Compliance | Description | Data | Compliance | Description | Data |
|---|---|---|---|---|---|
| No | Flare Type LT | N/A | N/A | Flare Type RT | N/A |
| No | Landing Slope (%) | 2.4 | Yes | DWS Length (in) | 24.0 |
| Yes | Landing X Slope (%) | 1.8 | No | DWS Full Width? | No |
| Yes | Gutter Ponding? | No | No | Gutter Slope (%) | 5.1 |

Possible Solutions:

**Remove & Replace Entire Ramp.  
Remove & Replace Gutter.**
