Access Compliance Report Public Rights-of-Way (Curb Ramps)

Intersection ID: 14442 Main Street: N_SHARON_AMITY_RD Cross Street: CENTRAL_AV Location: SW **ADA ID: 1D9A8C8D032E** Ramp Type: BlendTrans1 Initial Pass/Fail: Fail **Overall Compliance: No Severity Score:** 8.75

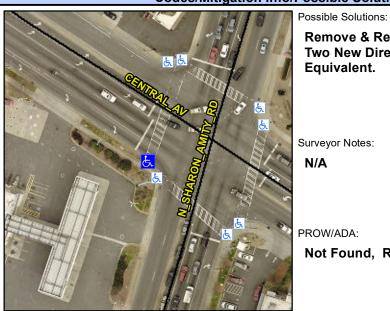
Field Measurements/Component Compliance					
Comp	liance Description	Data	Comp	liance Description	Data
N/A	Ramp Length (in)	69.0	Yes	BlendTrans Slope (%)	2.4
No	Ramp Width (in)	42.5	Yes	BlendTrans XSlope (%)	1.1
N/A	Flare Type LT	N/A	N/A	Flare Type RT	N/A
N/A	Flare Slope LT (%)	N/A	N/A	Flare Slope RT (%)	N/A
N/A	Flare Traversable LT?	N/A	N/A	Flare Traversable RT?	N/A
N/A	Landing Length (in)	N/A	N/A	DWS Provided?	N/A
N/A	Landing Width (in)	N/A	N/A	DWS Contrast?	N/A
N/A	Landing Slope (%)	N/A	N/A	DWS Length (in)	N/A
N/A	Landing X Slope (%)	N/A	N/A	DWS Full Width?	N/A
N/A	Landing Curb? (Y/N)	N/A	N/A	DWS Offset (in)	N/A
N/A	Shared Landing?	N/A			
N/A	Gutter Ponding?	N/A	N/A	Gutter Slope (%)	N/A
N/A	Gutter Lip Ht (in)	N/A	N/A	Gutter X Slope (%)	N/A
N/A	Painted X Walk1?	Yes	N/A	Painted X Walk2?	N/A
	X Walk 1 Direction	To NE		X Walk 2 Direction	N/A
	X Walk 1 Width (in)	105.0		X Walk 2 Width (in)	N/A
	X Walk 1 Slope (%)	1.6		X Walk 2 Slope (%)	N/A

X Walk 1 X Slope (%)	1.0		X Walk 2 X Slope (%)	N/A
N/A	Ramp inside XWalk1?	Yes	N/A	Ramp inside XWalk2?	N/A
	Road Slope (%)	1.0		Clear Space?	N/A
	Road X Slope (%)	1.6	N/A	Clear Space to XWalk (in)	N/A
N/A	Any Obstructions?	N/A	N/A	Storm Grate/Utility Hazard?	N/A
	Obstruction Type			Storm Grate/Utility Type	
		N/A			N/A
			Yes	Surface Condition? (G/P)	Good
	1 mm 1 m		No	Curb Slope (%)	30.9

CENTRAL AV Street 1 Name Stop Condition-Street 1 Signal Street 2 Name N/A Stop Condition-Street 2 N/A **Remove & Replace Curb Ramp With** Two New Directional Ramps or Equivalent.

Not Found, R304.5.1

3200.00
