Intersection ID: 10026804		Main Street: FOREST_POINT_CR		Cross Street: N/A		Location:		NE			
ADA ID: 1D9AF9F0993A		Ramp Type: PerpDiag		Initial Pass/Fail: Fail		Overall Compliance: No		Severity Score: 46.25			
Codes/Mitigation Info/Possible Solution				Field Measurements/Component Compliance							
<div>

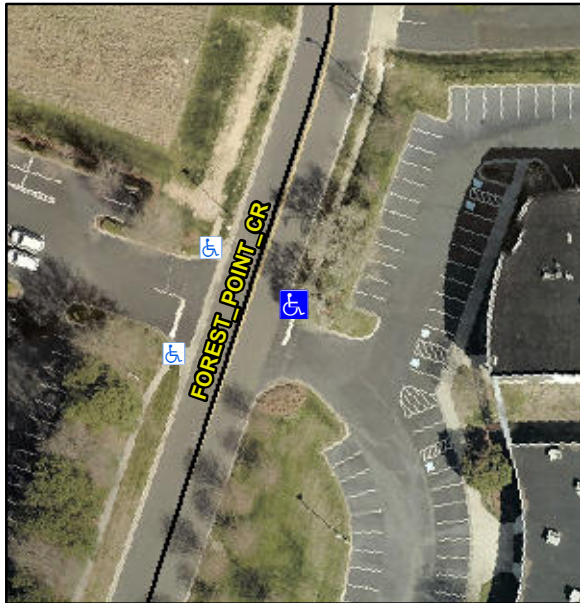
<p>Street 1 Name FOREST POINT CR</p><p>Stop Condition-Street 2 None</p><p>Street 2 Name ENTRANCE</p><p>Stop Condition-Street 1 StopSign</p></div>				Possible Solutions:		Compliance		Description		Data	
				Remove & Replace Curb Ramp With Two New Directional Ramps or Equivalent.		N/A		Ramp Length (in)		71.0	
Surveyor Notes:				N/A		No		Ramp Width (in)		38.0	
				PROW/ADA:		N/A		Flare Type LT		N/A	
Not Found, R304.5.1, R304.2.2, R304.5.3				N/A		N/A		Flare Slope LT (%)		N/A	
				N/A		N/A		Flare Slope RT (%)		N/A	
Total Cost:				\$ 3200.00		N/A		Flare Traversable LT?		N/A	
				N/A		N/A		Flare Traversable RT?		N/A

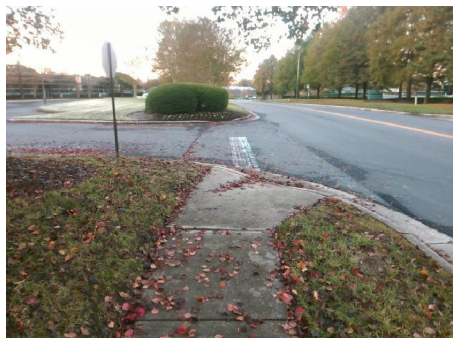
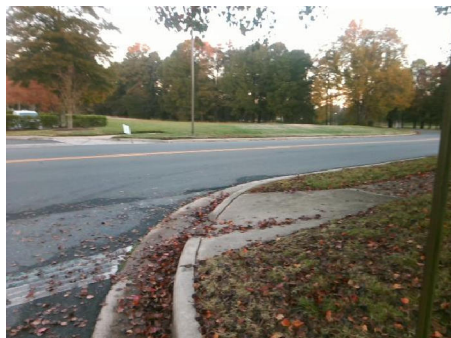
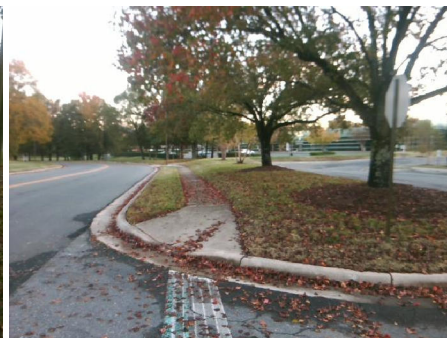
3.9				X Walk 2 Slope (%)		2.5	
				1.0				X Walk 2 X Slope (%)		3.7	
				N/A		N/A		Ramp inside XWalk2?		N/A	
				1.5		N/A		Clear Space?		N/A	
				3.7		N/A		Clear Space to XWalk (in)		N/A	
				N/A		N/A		Storm Grate/Utility Hazard?		N/A	
				N/A		N/A		Storm Grate/Utility Type		N/A	
				N/A		N/A		Storm Grate/Utility Type		N/A	
				N/A		Yes		Surface Condition? (G/P)		Good	
				N/A		N/A		Surface Condition? (G/P)		Good
