Access Compliance Report

Public Rights-of-Way

(Curb Ramps)

Intersection ID: 18033	Main Street: CHARLESTOWNE Manor_DRCross Street: WORCASTER_PL	Location: NE
ADA ID: 1D9E9D4FDDF2	Ramp Type: Directional1	Initial Pass/Fail: Fail Overall Compliance: No Severity Score: 8.75
Codes/Mitigation Info/Possible Solution		Field Measurements/Component Compliance

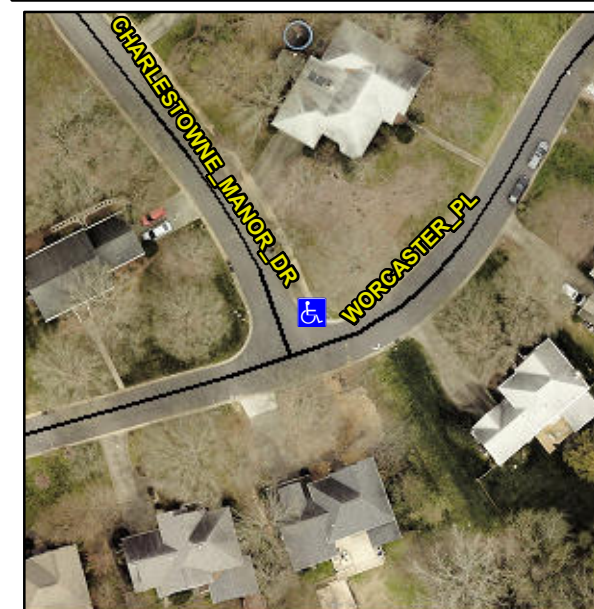
Compliance	Description	Data	Compliance	Description	Data
N/A	Ramp Length (in)	95.0	N/A	Grade Break?	N/A
No	Ramp Width (in)	45.0	N/A	Grade Break Slope (%)	0.0
Yes	Ramp Slope (%)	2.6	N/A	Grade Break XSlope (%)	0.0
Yes	Ramp XSlope (%)	1.1			
N/A	Flare Type LT	N/A	N/A	Flare Type RT	N/A
N/A	Flare Slope LT (%)	N/A	N/A	Flare Slope RT (%)	0.0
N/A	Flare Traversable LT?	N/A	N/A	Flare Traversable RT?	N/A
N/A	Landing Length (in)	0.0	N/A	DWS Provided?	N/A
N/A	Landing Width (in)	0.0	N/A	DWS Contrast?	N/A
N/A	Landing Slope (%)	0.0	N/A	DWS Length (in)	N/A
N/A	Landing X Slope (%)	0.0	N/A	DWS Full Width?	N/A
N/A	Landing Curb? (Y/N)	N/A	N/A	DWS Offset LT (in)	N/A
N/A	Shared Landing?	N/A	N/A	DWS Offset RT (in)	N/A
N/A	Gutter Ponding?	0.0	N/A	Gutter Slope (%)	N/A
N/A	Gutter Lip Ht (in)	0.0	N/A	Gutter X Slope (%)	N/A
N/A	Painted X Walk1?	No		Road Slope (%)	1.7
	X Walk 1 Direction	To SE		Road X Slope (%)	1.5
	X Walk 1 Width (in)	N/A		Clear Space?	N/A

X Walk 1 Slope (%)	1.7	N/A	Clear Space to XWalk (in)	N/A
	X Walk 1 X Slope (%)	1.5	N/A	Storm Grate/Utility Hazard?	N/A
N/A	Ramp inside XWalk1?	N/A		Storm Grate/Utility Type	
N/A	Any Obstructions?	N/A			N/A
	Obstruction Type		Yes	Surface Condition? (G/P)	Good
			N/A	Curb Slope (%)	32.9

Remove & Replace Entire Ramp.

R304.5.1

\$ 1600.00
