# Access Compliance Report

## Public Rights-of-Way

### (Curb Ramps)

Intersection ID: 29681	Main Street: DARLINGTON_RD	Cross Street: EQUESTRIAN_DR	Location:	N
ADA ID: 1DA4D0EBC970	Ramp Type: PerpDiag	Initial Pass/Fail: Fail	Overall Compliance: No	Severity Score: 10

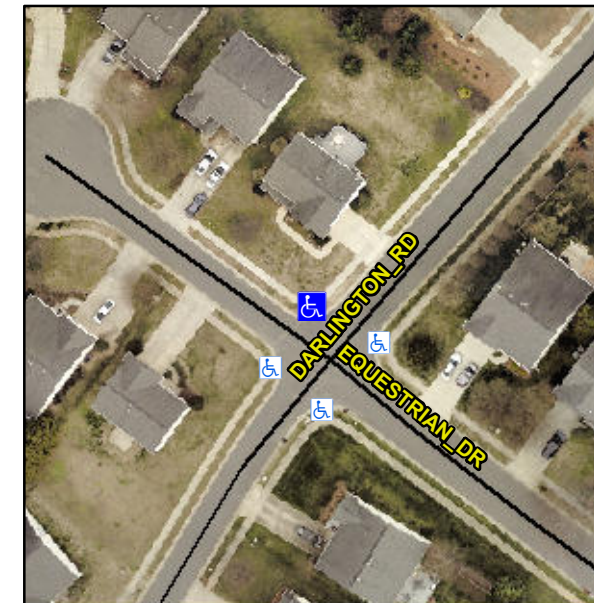
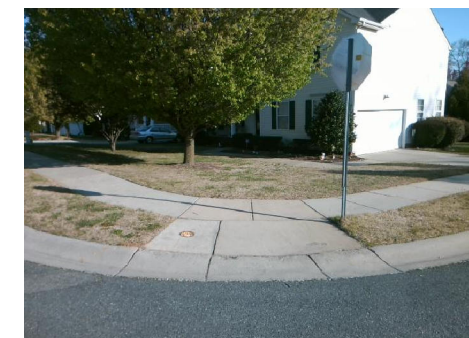
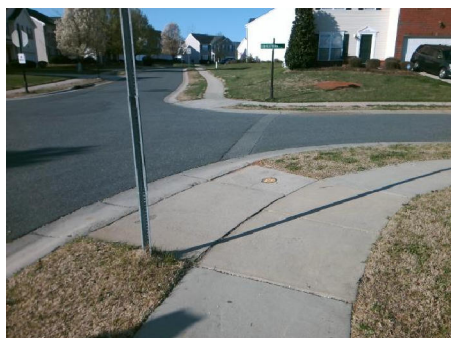
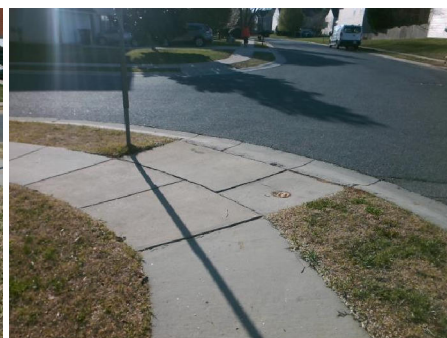
**Not Found, R304.5.1, R304.5.3**

Compliance	Description	Data	Compliance	Description	Data
N/A	Ramp Length (in)	49.5	Yes	Ramp Slope (%)	6.1
No	Ramp Width (in)	47.0	No	Ramp XSlope (%)	4.7
N/A	Flare Type LT	N/A	N/A	Flare Type RT	N/A
N/A	Flare Slope LT (%)	N/A	N/A	Flare Slope RT (%)	N/A
N/A	Flare Traversable LT?	N/A	N/A	Flare Traversable RT?	N/A
N/A	Landing Length (in)	N/A	N/A	DWS Provided?	N/A
N/A	Landing Width (in)	N/A	N/A	DWS Contrast?	N/A
N/A	Landing Slope (%)	N/A	N/A	DWS Length (in)	N/A
N/A	Landing X Slope (%)	N/A	N/A	DWS Full Width?	N/A
N/A	Landing Curb? (Y/N)	N/A	N/A	DWS Offset (in)	N/A
N/A	Shared Landing?	N/A			
N/A	Gutter Ponding?	N/A	N/A	Gutter Slope (%)	N/A
N/A	Gutter Lip Ht (in)	N/A	N/A	Gutter X Slope (%)	N/A
N/A	Painted X Walk1?	No	N/A	Painted X Walk2?	No
	X Walk 1 Direction	To SW		X Walk 2 Direction	To SE
N/A	X Walk 1 Width (in)	N/A	N/A	X Walk 2 Width (in)	N/A
	X Walk 1 Slope (%)	5.6		X Walk 2 Slope (%)	2.9
	X Walk 1 X Slope (%)	1.1		X Walk 2 X Slope (%)	4.2

N/A	Ramp inside XWalk1?	N/A	N/A	Ramp inside XWalk2?	N/A
	Road Slope (%)	4.1	N/A	Clear Space?	N/A
	Road X Slope (%)	4.8	N/A	Clear Space to XWalk (in)	N/A
N/A	Any Obstructions?	N/A	N/A	Storm Grate/Utility Hazard?	N/A
	Obstruction Type			Storm Grate/Utility Type	
		N/A			N/A
			Yes	Surface Condition? (G/P)	Good

**Remove & Replace Curb Ramp With Two New Directional Ramps or Equivalent.**
