Access Compliance Report

Public Rights-of-Way

| Intersection ID: 10022037 | Main Street: BRYANT_FARMS_RD | Cross Street: N/A | Location: NW |
| ADA ID: 1DAAE1DA939D | Ramp Type: BlendTrans1 | Initial Pass/Fail: Fail | Overall Compliance: No |

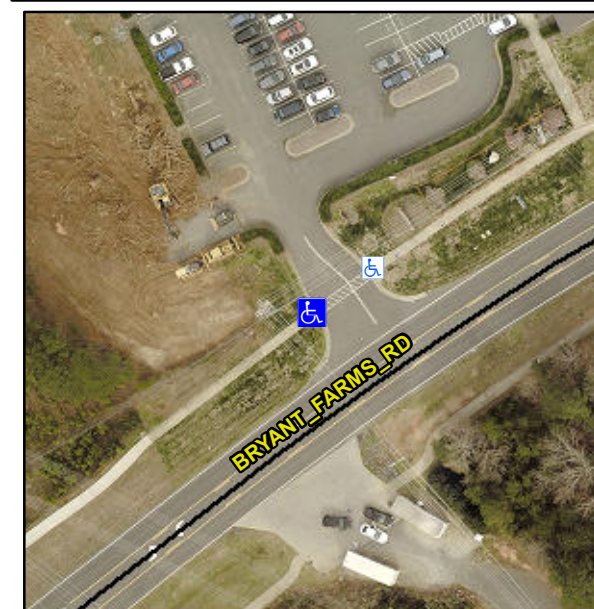
| Severity Score: 10 | | | |

R304.5.1

| Compliance | Description | Data | Compliance | Description | Data |
|---|---|---|---|---|---|
| No | Ramp Width (in) | 46.0 | Yes | BlendTrans XSlope (%) | 2.1 |

Remove & Replace Curb Ramp With Two New Directional Ramps or Equivalent.

Total Cost: \$ 3200.00
