Access Compliance Report

Public Rights-of-Way

(Curb Ramps)

Intersection ID: 5563	Main Street: N_I-77_EXIT_16_RA	Cross Street: REAMES_RD	Location: NW
ADA ID: 1DB36487AD8E	Ramp Type: Perp	Initial Pass/Fail: Fail	Overall Compliance: No
Severity Score: 21.25			
Codes/Mitigation Info/Possible Solution		Field Measurements/Component Compliance

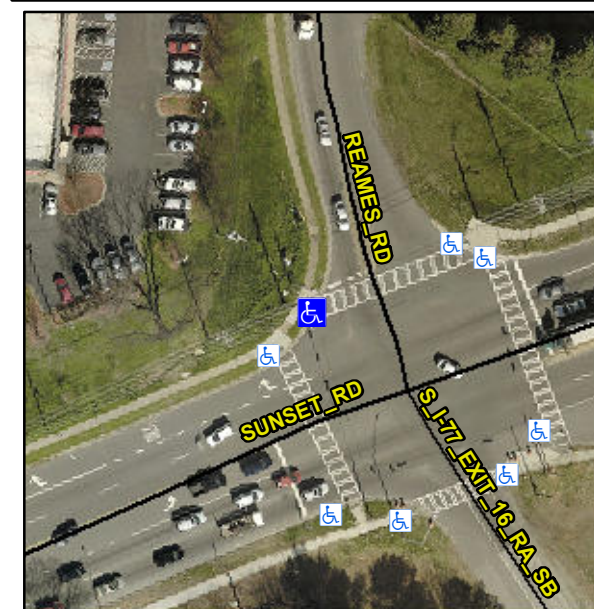
Not Found, R304.5.1, R304.2.2

Compliance	Description	Data	Compliance	Description	Data
N/A	Ramp Length (in)	54.0	No	Ramp Slope (%)	9.4
No	Ramp Width (in)	46.0	Yes	Ramp XSlope (%)	0.7
N/A	Flare Type LT	N/A	N/A	Flare Type RT	N/A
N/A	Flare Slope LT (%)	N/A	N/A	Flare Slope RT (%)	N/A
N/A	Flare Traversable LT?	N/A	N/A	Flare Traversable RT?	N/A
N/A	Landing Length (in)	N/A	N/A	DWS Provided?	N/A
N/A	Landing Width (in)	N/A	N/A	DWS Contrast?	N/A
N/A	Landing Slope (%)	N/A	N/A	DWS Length (in)	N/A
N/A	Landing X Slope (%)	N/A	N/A	DWS Full Width?	N/A
N/A	Landing Curb? (Y/N)	N/A	N/A	DWS Offset (in)	N/A
N/A	Shared Landing?	N/A			
N/A	Gutter Ponding?	N/A	N/A	Gutter Slope (%)	N/A
N/A	Gutter Lip Ht (in)	N/A	N/A	Gutter X Slope (%)	N/A
N/A	Painted X Walk1?	Yes	N/A	Painted X Walk2?	N/A
	X Walk 1 Direction	To E		X Walk 2 Direction	N/A
N/A	X Walk 1 Width (in)	112.0	N/A	X Walk 2 Width (in)	N/A
	X Walk 1 Slope (%)	3.2		X Walk 2 Slope (%)	N/A
	X Walk 1 X Slope (%)	4.5		X Walk 2 X Slope (%)	N/A

N/A	Ramp inside XWalk1?	Yes	N/A	Ramp inside XWalk2?	N/A
	Road Slope (%)	N/A	N/A	Clear Space?	N/A
	Road X Slope (%)	N/A	N/A	Clear Space to XWalk (in)	N/A
N/A	Any Obstructions?	N/A	N/A	Storm Grate/Utility Hazard?	N/A
	Obstruction Type			Storm Grate/Utility Type	
		N/A			N/A
		Yes		Surface Condition? (G/P)	Good

Possible Solutions:

Remove & Replace Entire Ramp.

Total Cost: \$ 1850.00
