## **Access Compliance Report Public Rights-of-Way** (Curb Ramps)

Intersection ID: 14091 Main Street: E\_7TH\_ST Cross Street: N\_CASWELL\_RD Location: SE **Overall Compliance: No Severity Score:** ADA ID: 1DB4E72BD7A0 Ramp Type: Perp Initial Pass/Fail: Fail 12.5

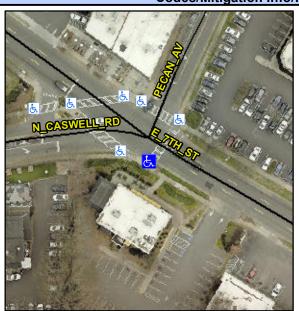
Field Measurements/Component Compliance								
Comp	liance Description	Data	Comp	oliance	Description	Data		
N/A	Ramp Length (in)	114.0	Yes	Ram	Slope (%)	7.1		
Yes	Ramp Width (in)	48.0	No	Ram	XSlope (%)	5.2		
N/A	Flare Type LT	N/A	N/A	Flare	Type RT	N/A		
N/A	Flare Slope LT (%)	N/A	N/A	Flare	Slope RT (%)	N/A		
N/A	Flare Traversable LT?	N/A	N/A	Flare	Traversable RT?	N/A		
N/A	Landing Length (in)	N/A	N/A	DWS	Provided?	N/A		
N/A	Landing Width (in)	N/A	N/A	DWS	Contrast?	N/A		
N/A	Landing Slope (%)	N/A	N/A	DWS	Length (in)	N/A		
N/A	Landing X Slope (%)	N/A	N/A	DWS	Full Width?	N/A		
N/A	Landing Curb? (Y/N)	N/A	N/A	DWS	Offset (in)	N/A		
N/A	Shared Landing?	N/A						
N/A	Gutter Ponding?	N/A	N/A	Gutte	r Slope (%)	N/A		
N/A	Gutter Lip Ht (in)	N/A	N/A	Gutte	r X Slope (%)	N/A		
N/A	Painted X Walk1?	Yes	N/A	Paint	ed X Walk2?	N/A		
	X Walk 1 Direction	To NE		X Wa	lk 2 Direction	N/A		
N/A	X Walk 1 Width (in)	94.0	N/A	X Wa	lk 2 Width (in)	N/A

X Walk 1 Slope (%)	4.0		X Wa	lk 2 Slope (%)	N/A		
	X Walk 1 X Slope (%)	1.0		X Wa	lk 2 X Slope (%)	N/A		
N/A	Ramp inside XWalk1?	Yes	N/A	Ram	inside XWalk2?	N/A		
	Road Slope (%)	N/A	N/A	Clear	Space?	N/A		
	Road X Slope (%)	N/A	N/A	Clear	Space to XWalk (in)	N/A		
N/A	Any Obstructions?	N/A	N/A	Storn	n Grate/Utility Hazard?	N/A		
	Obstruction Type			Storn	n Grate/Utility Type			
		N/A				N/A

OSSIDIE SOIGHOII	
Possible Solutions:	Co
Remove & Replace Entire Ramp.	N/A
	Ye
	N/A
	N/A
	N/A
	N/A
Surveyor Notes:	N/A
N/A	N/A
	N/A
	N/A
	N/A
PROW/ADA:	N/A
Not Found, R304.5.3	N/A
	N/A
	N/A
	N/A
