Access Compliance Report

Public Rights-of-Way

(Curb Ramps)

Intersection ID: 5481	Main Street: MCCLURE_CR	Cross Street: PLEASANT_GROVE_RD	Location: W
ADA ID: 1DBFD23D69DA	Ramp Type: Directional1	Initial Pass/Fail: Fail	Overall Compliance: No
		Severity Score: 12.5

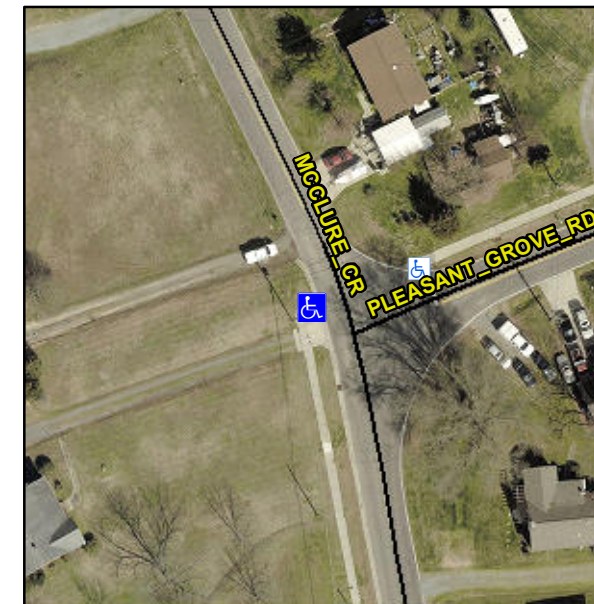
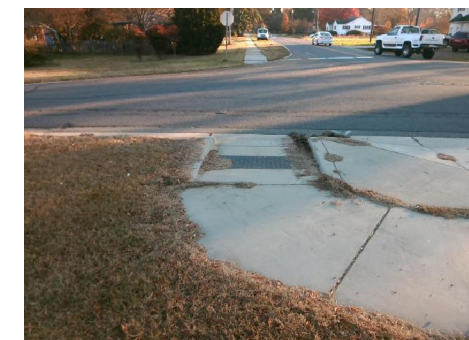
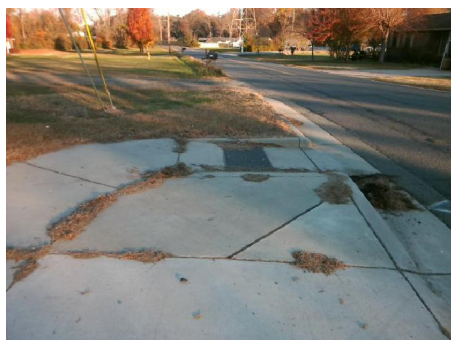
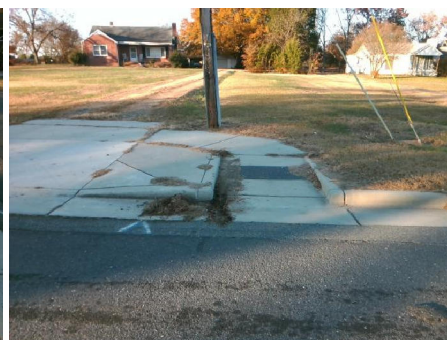
R304.2.2

Compliance	Description	Data	Compliance	Description	Data
N/A	Ramp Length (in)	72.5	N/A	Grade Break?	N/A
Yes	Ramp Width (in)	58.0	N/A	Grade Break Slope (%)	0.0
No	Ramp Slope (%)	8.5	N/A	Grade Break XSlope (%)	0.0
Yes	Ramp XSlope (%)	0.4			
N/A	Flare Type LT	N/A	N/A	Flare Type RT	N/A
N/A	Flare Slope LT (%)	N/A	N/A	Flare Slope RT (%)	0.0
N/A	Flare Traversable LT?	N/A	N/A	Flare Traversable RT?	N/A
N/A	Landing Length (in)	0.0	N/A	DWS Provided?	N/A
N/A	Landing Width (in)	0.0	N/A	DWS Contrast?	N/A
N/A	Landing Slope (%)	0.0	N/A	DWS Length (in)	N/A
N/A	Landing X Slope (%)	0.0	N/A	DWS Full Width?	N/A
N/A	Landing Curb? (Y/N)	N/A	N/A	DWS Offset LT (in)	N/A
N/A	Shared Landing?	N/A	N/A	DWS Offset RT (in)	N/A
N/A	Gutter Ponding?	0.0	N/A	Gutter Slope (%)	N/A
N/A	Gutter Lip Ht (in)	0.0	N/A	Gutter X Slope (%)	N/A
N/A	Painted X Walk1?	No		Road Slope (%)	5.1
	X Walk 1 Direction	To E		Road X Slope (%)	0.0
	X Walk 1 Width (in)	N/A		Clear Space?	N/A

X Walk 1 Slope (%)	5.1	N/A	Clear Space to XWalk (in)	N/A
	X Walk 1 X Slope (%)	0.0	N/A	Storm Grate/Utility Hazard?	N/A
N/A	Ramp inside XWalk1?	N/A		Storm Grate/Utility Type	
N/A	Any Obstructions?	N/A			N/A
	Obstruction Type		Yes	Surface Condition? (G/P)	Good
			N/A	Curb Slope (%)	6.5

Remove & Replace Entire Ramp.
