# Access Compliance Report

## Public Rights-of-Way

### (Curb Ramps)

| Intersection ID: 42359 | Main Street: HERON_GLEN_DR | Cross Street: WRENS_NEST_LN | Location: | W |

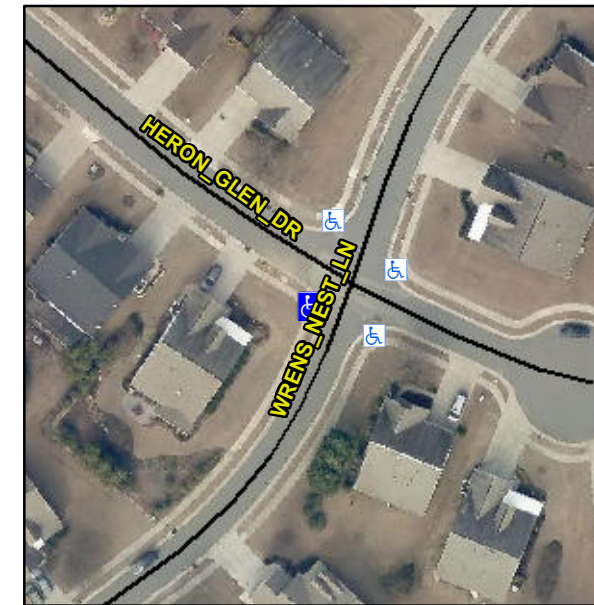
| ADA ID: 1DCEF009FDF6 | Ramp Type: PerpDiag | Initial Pass/Fail: Pass | Overall Compliance: No | Severity Score: 10 |

**R304.2.2-Perp, R304.3.2-Para, R305, R304.5.3**

| Compliance | Description | Data | Compliance | Description | Data |
|---|---|---|---|---|---|
| Yes | Landing Length (in) | 48.0 | No | DWS Provided? | No |
| No | Landing Slope (%) | 2.8 | N/A | DWS Length (in) | N/A |
| Yes | Gutter Lip Ht (in) | 0.0 | No | Gutter X Slope (%) | 3.3 |

**Remove & Replace Curb Ramp With Two New Directional Ramps or Equivalent. Remove & Replace Gutter.**
