Access Compliance Report

Public Rights-of-Way

(Curb Ramps)

| Intersection ID: 44539 | Main Street: FORUM_AV | Cross Street: BALLANTYNE_COMMONS_PY | Location: NE |

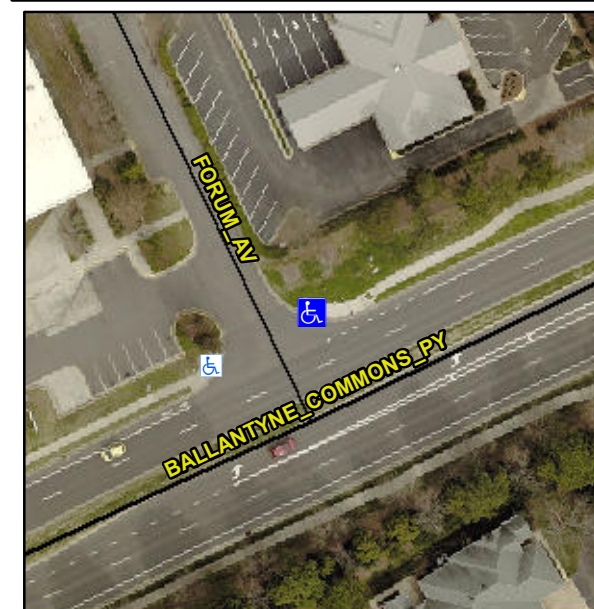
Not Found, R304.5.1, R304.5.3

| Compliance | Description | Data | Compliance | Description | Data |
|---|---|---|---|---|---|
| N/A | Ramp Length (in) | 84.5 | Yes | Ramp Slope (%) | 7.2 |
| No | Ramp Width (in) | 47.0 | No | Ramp XSlope (%) | 10.3 |

Remove & Replace Entire Ramp.
