Access Compliance Report

Public Rights-of-Way

(Curb Ramps)

Intersection ID: 5646	Main Street: MCCULLOUGH_DR	Cross Street: COLLINS-AIKMAN_DR	Location: NW
ADA ID: 1DDF492DDBF6	Ramp Type: BlendTrans1	Initial Pass/Fail: Fail	Overall Compliance: No
		Severity Score: 10

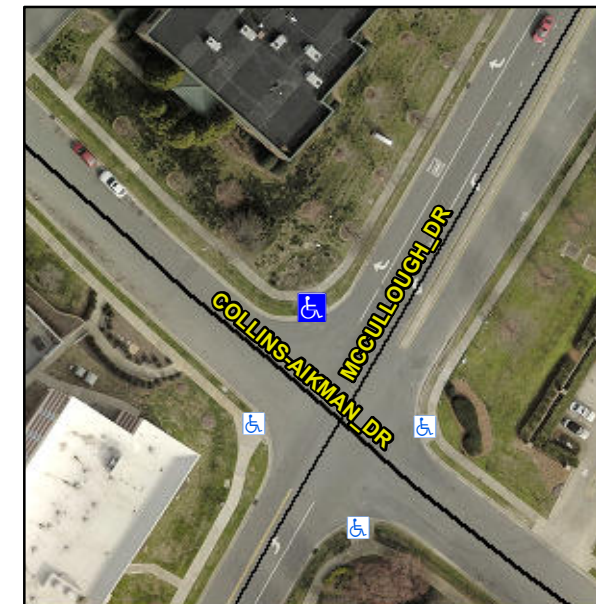
Not Found, R304.5.1, R304.5.3

Compliance	Description	Data	Compliance	Description	Data
N/A	Ramp Length (in)	98.0	Yes	BlendTrans Slope (%)	4.6
No	Ramp Width (in)	47.0	No	BlendTrans XSlope (%)	3.4
N/A	Flare Type LT	N/A	N/A	Flare Type RT	N/A
N/A	Flare Slope LT (%)	N/A	N/A	Flare Slope RT (%)	N/A
N/A	Flare Traversable LT?	N/A	N/A	Flare Traversable RT?	N/A
N/A	Landing Length (in)	N/A	N/A	DWS Provided?	N/A
N/A	Landing Width (in)	N/A	N/A	DWS Contrast?	N/A
N/A	Landing Slope (%)	N/A	N/A	DWS Length (in)	N/A
N/A	Landing X Slope (%)	N/A	N/A	DWS Full Width?	N/A
N/A	Landing Curb? (Y/N)	N/A	N/A	DWS Offset (in)	N/A
N/A	Shared Landing?	N/A			
N/A	Gutter Ponding?	N/A	N/A	Gutter Slope (%)	N/A
N/A	Gutter Lip Ht (in)	N/A	N/A	Gutter X Slope (%)	N/A
N/A	Painted X Walk1?	No	N/A	Painted X Walk2?	No
	X Walk 1 Direction	To SW		X Walk 2 Direction	To SE
	X Walk 1 Width (in)	N/A		X Walk 2 Width (in)	N/A
	X Walk 1 Slope (%)	7.1		X Walk 2 Slope (%)	4.3
	X Walk 1 X Slope (%)	0.3		X Walk 2 X Slope (%)	8.5

N/A	Ramp inside XWalk1?	N/A	N/A	Ramp inside XWalk2?	N/A
	Road Slope (%)	8.3		Clear Space?	N/A
	Road X Slope (%)	5.5	N/A	Clear Space to XWalk (in)	N/A
N/A	Any Obstructions?	N/A	N/A	Storm Grate/Utility Hazard?	N/A
	Obstruction Type			Storm Grate/Utility Type	
		N/A			N/A
			Yes	Surface Condition? (G/P)	Good
			No	Curb Slope (%)	21.0

Remove & Replace Curb Ramp With Two New Directional Ramps or Equivalent.
