Access Compliance Report

Public Rights-of-Way

(Curb Ramps)

Intersection ID: 25829	Main Street: GREYSON RIDGE DR	Cross Street: HIGH RIDGE RD	Location: SW
ADA ID: 1DDFADDCA2AE	Ramp Type: PerpDiag	Initial Pass/Fail: Fail	Overall Compliance: No
		Severity Score: 30

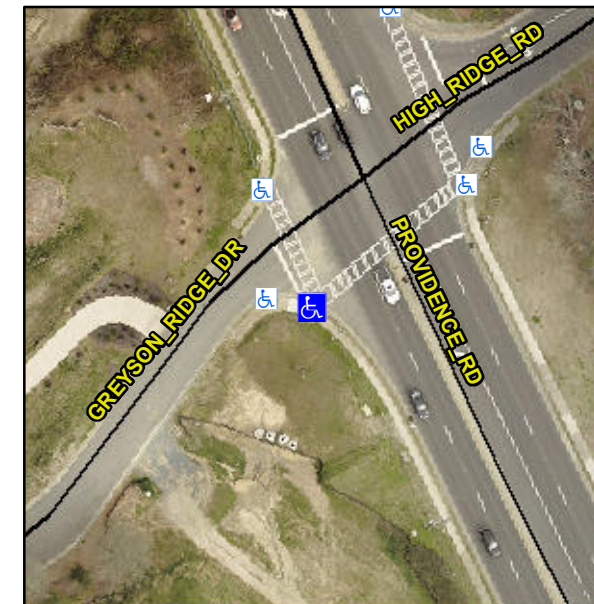
Compliance	Description	Data	Compliance	Description	Data
N/A	Ramp Length (in)	82.5	No	Ramp Slope (%)	9.2
No	Ramp Width (in)	34.0	Yes	Ramp XSlope (%)	1.8
N/A	Flare Type LT	N/A	N/A	Flare Type RT	N/A
N/A	Flare Slope LT (%)	N/A	N/A	Flare Slope RT (%)	N/A
N/A	Flare Traversable LT?	N/A	N/A	Flare Traversable RT?	N/A
N/A	Landing Length (in)	N/A	N/A	DWS Provided?	N/A
N/A	Landing Width (in)	N/A	N/A	DWS Contrast?	N/A
N/A	Landing Slope (%)	N/A	N/A	DWS Length (in)	N/A
N/A	Landing X Slope (%)	N/A	N/A	DWS Full Width?	N/A
N/A	Landing Curb? (Y/N)	N/A	N/A	DWS Offset (in)	N/A
N/A	Shared Landing?	N/A			
N/A	Gutter Ponding?	N/A	N/A	Gutter Slope (%)	N/A
N/A	Gutter Lip Ht (in)	N/A	N/A	Gutter X Slope (%)	N/A
N/A	Painted X Walk1?	Yes	N/A	Painted X Walk2?	Yes
	X Walk 1 Direction	To NE		X Walk 2 Direction	To NW
N/A	X Walk 1 Width (in)	82.0	N/A	X Walk 2 Width (in)	77.5
	X Walk 1 Slope (%)	2.4		X Walk 2 Slope (%)	0.2
	X Walk 1 X Slope (%)	1.6		X Walk 2 X Slope (%)	5.3

N/A	Ramp inside XWalk1?	Yes	N/A	Ramp inside XWalk2?	Yes
	Road Slope (%)	1.0	N/A	Clear Space?	N/A
	Road X Slope (%)	3.4	N/A	Clear Space to XWalk (in)	N/A
N/A	Any Obstructions?	N/A	N/A	Storm Grate/Utility Hazard?	N/A
	Obstruction Type			Storm Grate/Utility Type	
		N/A			N/A
		Yes		Surface Condition? (G/P)	Good

Remove & Replace Curb Ramp With Two New Directional Ramps or Equivalent.

R304.5.1, R304.2.2
