Intersection ID: 2910	Main Street: RIDGEFIELD_DR	Cross Street: SWANSTON_DR	Location:	SW
ADA ID: 1DFBA6157605	Ramp Type: PerpDiag	Initial Pass/Fail: Fail	Overall Compliance: No	Severity Score: 8.75

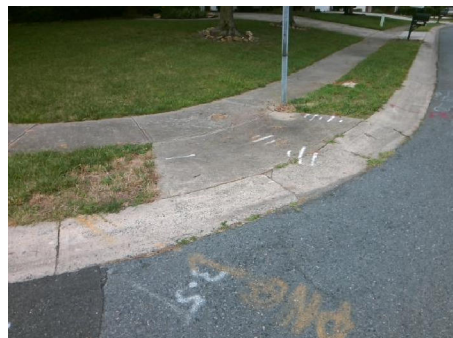
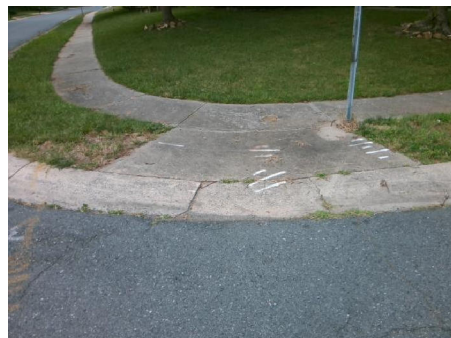
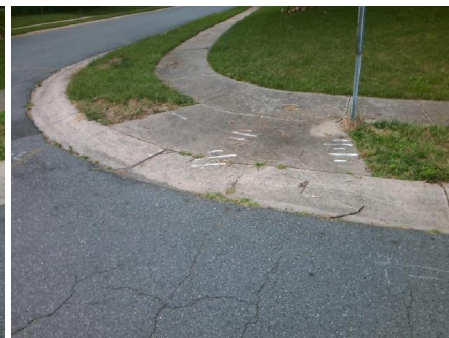
Compliance	Description	Data	Compliance	Description	Data
N/A	Ramp Length (in)	49.0	Yes	Ramp Slope (%)	6.1
No	Ramp Width (in)	36.0	Yes	Ramp XSlope (%)	1.9
N/A	Flare Type LT	N/A	N/A	Flare Type RT	N/A
N/A	Flare Slope LT (%)	N/A	N/A	Flare Slope RT (%)	N/A
N/A	Flare Traversable LT?	N/A	N/A	Flare Traversable RT?	N/A
N/A	Landing Length (in)	N/A	N/A	DWS Provided?	N/A
N/A	Landing Width (in)	N/A	N/A	DWS Contrast?	N/A
N/A	Landing Slope (%)	N/A	N/A	DWS Length (in)	N/A
N/A	Landing X Slope (%)	N/A	N/A	DWS Full Width?	N/A
N/A	Landing Curb? (Y/N)	N/A	N/A	DWS Offset (in)	N/A
N/A	Shared Landing?	N/A			
N/A	Gutter Ponding?	N/A	N/A	Gutter Slope (%)	N/A
N/A	Gutter Lip Ht (in)	N/A	N/A	Gutter X Slope (%)	N/A
N/A	Painted X Walk1?	No	N/A	Painted X Walk2?	No
	X Walk 1 Direction	To E		X Walk 2 Direction	To N
N/A	X Walk 1 Width (in)	N/A	N/A	X Walk 2 Width (in)	N/A
	X Walk 1 Slope (%)	1.6		X Walk 2 Slope (%)	0.4
	X Walk 1 X Slope (%)	1.7		X Walk 2 X Slope (%)	1.8

N/A	Ramp inside XWalk1?	N/A	N/A	Ramp inside XWalk2?	N/A
	Road Slope (%)	1.5	N/A	Clear Space?	N/A
	Road X Slope (%)	1.4	N/A	Clear Space to XWalk (in)	N/A
N/A	Any Obstructions?	N/A	N/A	Storm Grate/Utility Hazard?	N/A
	Obstruction Type			Storm Grate/Utility Type	
		N/A			N/A
			Yes	Surface Condition? (G/P)	Good

**Remove & Replace Curb Ramp With Two New Directional Ramps or Equivalent.**
