Access Compliance Report

Public Rights-of-Way

(Curb Ramps)

Intersection ID: 11164	Main Street: CAMP_GREENE_ST	Cross Street: FREEDOM_DR	Location: E
ADA ID: 1DFBE8BFE37B	Ramp Type: Perp	Initial Pass/Fail: Fail	Overall Compliance: No
Severity Score: 13.75			
Codes/Mitigation Info/Possible Solution		Field Measurements/Component Compliance

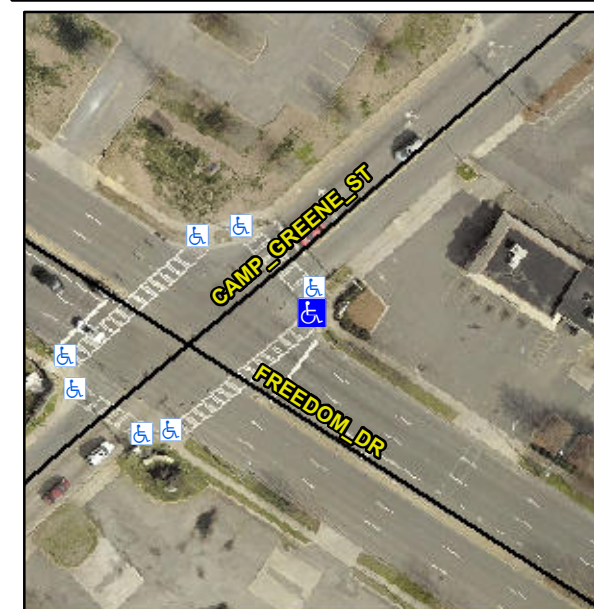
Not Found, R304.2.2

Compliance	Description	Data	Compliance	Description	Data
N/A	Ramp Length (in)	76.0	No	Ramp Slope (%)	8.8
Yes	Ramp Width (in)	48.0	Yes	Ramp XSlope (%)	4.8
N/A	Flare Type LT	N/A	N/A	Flare Type RT	N/A
N/A	Flare Slope LT (%)	N/A	N/A	Flare Slope RT (%)	N/A
N/A	Flare Traversable LT?	N/A	N/A	Flare Traversable RT?	N/A
N/A	Landing Length (in)	N/A	N/A	DWS Provided?	N/A
N/A	Landing Width (in)	N/A	N/A	DWS Contrast?	N/A
N/A	Landing Slope (%)	N/A	N/A	DWS Length (in)	N/A
N/A	Landing X Slope (%)	N/A	N/A	DWS Full Width?	N/A
N/A	Landing Curb? (Y/N)	N/A	N/A	DWS Offset (in)	N/A
N/A	Shared Landing?	N/A			
N/A	Gutter Ponding?	N/A	N/A	Gutter Slope (%)	N/A
N/A	Gutter Lip Ht (in)	N/A	N/A	Gutter X Slope (%)	N/A
N/A	Painted X Walk1?	Yes	N/A	Painted X Walk2?	N/A
	X Walk 1 Direction	To SW		X Walk 2 Direction	N/A
N/A	X Walk 1 Width (in)	70.0	N/A	X Walk 2 Width (in)	N/A
	X Walk 1 Slope (%)	0.7		X Walk 2 Slope (%)	N/A
	X Walk 1 X Slope (%)	6.8		X Walk 2 X Slope (%)	N/A

N/A	Ramp inside XWalk1?	Yes	N/A	Ramp inside XWalk2?	N/A
	Road Slope (%)	N/A	N/A	Clear Space?	N/A
	Road X Slope (%)	N/A	N/A	Clear Space to XWalk (in)	N/A
N/A	Any Obstructions?	N/A	N/A	Storm Grate/Utility Hazard?	N/A
	Obstruction Type			Storm Grate/Utility Type	
		N/A			N/A
		Yes		Surface Condition? (G/P)	Good

Possible Solutions:

Remove & Replace Entire Ramp.

Total Cost: \$ 1850.00
