Access Compliance Report Public Rights-of-Way (Curb Ramps)

Intersection ID: 7963 Main Street: ASHFORD_ST Cross Street: DAVID_AV Location:

Overall Compliance: No ADA ID: 1DFF4A78B337 Ramp Type: Perp Initial Pass/Fail: Fail Severity Score: 21.25

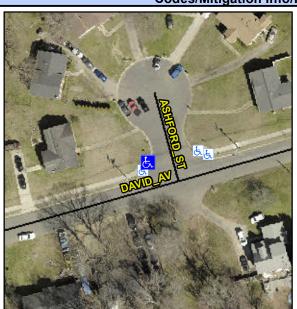
Field Measurements/Component Compliance							
Compliance Description			Data	Comp	Data			
	N/A	Ramp Length (in)	47.0	Yes	Ramp Slope (%)	5.5		
	No	Ramp Width (in)	47.5	No	Ramp XSlope (%)	5.2		
	N/A	Flare Type LT	N/A	N/A	Flare Type RT	N/A		
	N/A	Flare Slope LT (%)	N/A	N/A	Flare Slope RT (%)	N/A		
	N/A	Flare Traversable LT?	N/A	N/A	Flare Traversable RT?	N/A		
	N/A	Landing Length (in)	N/A	N/A	DWS Provided?	N/A		
	N/A	Landing Width (in)	N/A	N/A	DWS Contrast?	N/A		
	N/A	Landing Slope (%)	N/A	N/A	DWS Length (in)	N/A		
	N/A	Landing X Slope (%)	N/A	N/A	DWS Full Width?	N/A		
	N/A	Landing Curb? (Y/N)	N/A	N/A	DWS Offset (in)	N/A		
	N/A	Shared Landing?	N/A					
	N/A	Gutter Ponding?	N/A	N/A	Gutter Slope (%)	N/A		
	N/A	Gutter Lip Ht (in)	N/A	N/A	Gutter X Slope (%)	N/A		
	N/A	Painted X Walk1?	No	N/A	Painted X Walk2?	N/A		
		X Walk 1 Direction	To E		X Walk 2 Direction	N/A		
	N/A	X Walk 1 Width (in)	N/A	N/A	X Walk 2 Width (in)	N/A

X Walk 1 Slope (%)	7.0		X Walk 2 Slope (%)	N/A		
		X Walk 1 X Slope (%)	0.3		X Walk 2 X Slope (%)	N/A		
	N/A	Ramp inside XWalk1?	N/A	N/A	Ramp inside XWalk2?	N/A		
		Road Slope (%)	N/A	N/A	Clear Space?	N/A		
		Road X Slope (%)	N/A	N/A	Clear Space to XWalk (in)	N/A		
	N/A	Any Obstructions?	N/A	N/A	Storm Grate/Utility Hazard?	N/A		
		Obstruction Type		l	Storm Grate/Utility Type			
			N/A			N/A		
				Yes	Surface Condition? (G/P)	Good

Possible Solutions:	<u>c</u>
Remove & Replace Entire Ramp.	N
	N
	N
	N
	N
	N
Surveyor Notes:	N
N/A	N
	N
	N
	N
PROW/ADA:	N
Not Found, R304.5.1, R304.5.3	N
	N
	N
