Access Compliance Report

Public Rights-of-Way

(Curb Ramps)

Intersection ID: 10711	Main Street: EFFINGHAM_RD	Cross Street: TUCKASEEGEE_RD	Location: S
ADA ID: 1E004F97D164	Ramp Type: Perp	Initial Pass/Fail: Fail	Overall Compliance: No
		Severity Score: 12.5

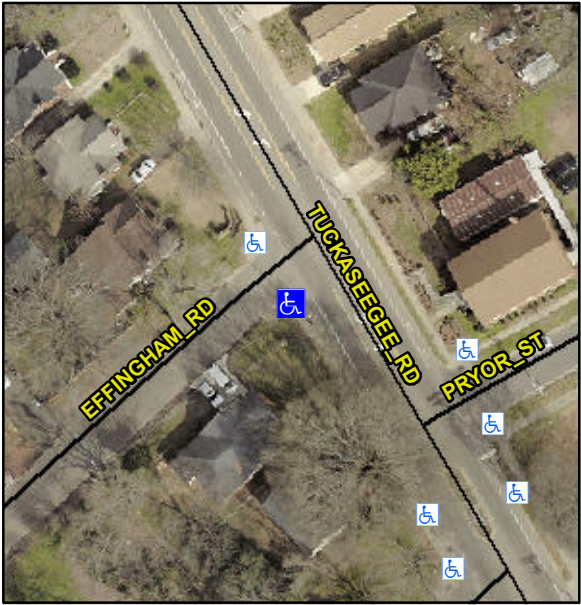
Possible Solutions:		Compliance	Description	Data
	Remove & Replace Entire Ramp.		No	Ramp Length (in)	74.0
			Yes	Ramp Width (in)	48.0
			N/A	Flare Type LT	N/A
			N/A	Flare Slope LT (%)	N/A
			N/A	Flare Traversable LT?	N/A
			N/A	Landing Length (in)	N/A
			N/A	Landing Width (in)	N/A
			N/A	Landing Slope (%)	N/A
			N/A	Landing X Slope (%)	N/A
<p>Surveyor Notes:</p> <p>N/A</p> <p>PROW/ADA:</p> <p>Not Found, R304.2.2</p>			N/A	Flare Type RT	N/A
			N/A	Flare Slope RT (%)	N/A
			N/A	Flare Traversable RT?	N/A
			N/A	DWS Provided?	N/A
			N/A	DWS Contrast?	N/A
			N/A	DWS Length (in)	N/A
			N/A	DWS Full Width?	N/A
			N/A	DWS Offset (in)	N/A
			N/A	Shared Landing?	N/A
			N/A	Gutter Ponding?	Yes
<p>Street 1 Name</p> <p>Stop Condition-Street 2</p> <p>Street 2 Name</p> <p>Stop Condition-Street 1</p>			N/A	Gutter Lip Ht (in)	N/A
			N/A	Painted X Walk1?	No

X Walk 1 Direction	To N
			N/A	X Walk 1 Width (in)	N/A
				X Walk 1 Slope (%)	5.5
				X Walk 1 X Slope (%)	0.9
			N/A	Ramp inside XWalk1?	N/A
			N/A	Road Slope (%)	N/A
			N/A	Road X Slope (%)	N/A
			N/A	Any Obstructions?	N/A
<p>Total Cost:</p> <p>\$ 1850.00</p>			N/A	Obstruction Type	
			N/A	Clear Space?	N/A
			N/A	Clear Space to XWalk (in)	N/A
			N/A	Storm Grate/Utility Hazard?	N/A
			N/A	Storm Grate/Utility Type	
			N/A		N/A
			Yes	Surface Condition? (G/P)	Good
