# Access Compliance Report

## Public Rights-of-Way

### (Curb Ramps)

Intersection ID: 10033070	Main Street: NORTH_COMMUNITY_HOUSE_RD	Cross Street: N/A	Location: SW
ADA ID: 1E06B475CAEB	Ramp Type: Perp	Initial Pass/Fail: Fail	Overall Compliance: No
Severity Score: 25			
Codes/Mitigation Info/Possible Solution		Field Measurements/Component Compliance

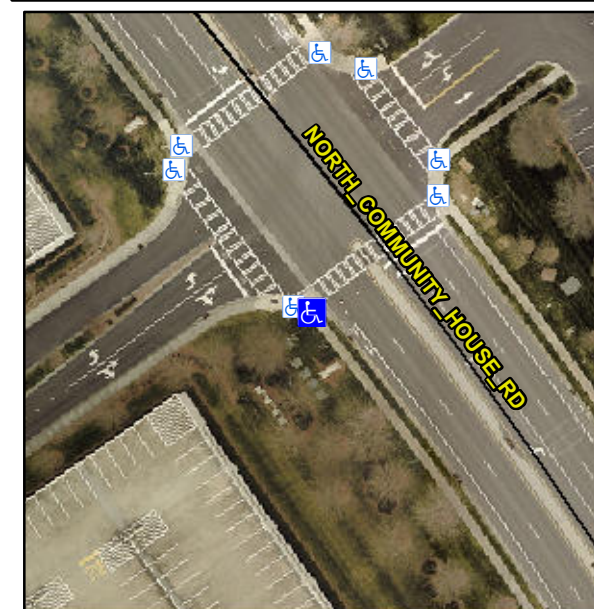
**Not Found, R304.2.2, R304.5.3**

Compliance	Description	Data	Compliance	Description	Data
N/A	Ramp Length (in)	24.0	No	Ramp Slope (%)	10.0
Yes	Ramp Width (in)	48.0	No	Ramp XSlope (%)	6.6
N/A	Flare Type LT	N/A	N/A	Flare Type RT	N/A
N/A	Flare Slope LT (%)	N/A	N/A	Flare Slope RT (%)	N/A
N/A	Flare Traversable LT?	N/A	N/A	Flare Traversable RT?	N/A
N/A	Landing Length (in)	N/A	N/A	DWS Provided?	N/A
N/A	Landing Width (in)	N/A	N/A	DWS Contrast?	N/A
N/A	Landing Slope (%)	N/A	N/A	DWS Length (in)	N/A
N/A	Landing X Slope (%)	N/A	N/A	DWS Full Width?	N/A
N/A	Landing Curb? (Y/N)	N/A	N/A	DWS Offset (in)	N/A
N/A	Shared Landing?	N/A			
N/A	Gutter Ponding?	N/A	N/A	Gutter Slope (%)	N/A
N/A	Gutter Lip Ht (in)	N/A	N/A	Gutter X Slope (%)	N/A
N/A	Painted X Walk1?	Yes	N/A	Painted X Walk2?	N/A
	X Walk 1 Direction	To NE		X Walk 2 Direction	N/A
N/A	X Walk 1 Width (in)	111.5	N/A	X Walk 2 Width (in)	N/A
	X Walk 1 Slope (%)	3.9		X Walk 2 Slope (%)	N/A
	X Walk 1 X Slope (%)	2.5		X Walk 2 X Slope (%)	N/A

N/A	Ramp inside XWalk1?	Yes	N/A	Ramp inside XWalk2?	N/A
	Road Slope (%)	N/A	N/A	Clear Space?	N/A
	Road X Slope (%)	N/A	N/A	Clear Space to XWalk (in)	N/A
N/A	Any Obstructions?	N/A	N/A	Storm Grate/Utility Hazard?	N/A
	Obstruction Type			Storm Grate/Utility Type	
		N/A			N/A
		Yes		Surface Condition? (G/P)	Good

Possible Solutions:

**Remove & Replace Entire Ramp.**

Total Cost: \$ 1850.00
