Access Compliance Report

Public Rights-of-Way

(Curb Ramps)

Intersection ID: 26441	Main Street: GRABURN_RD	Cross Street: JOHNSTON_RD	Location: SW
ADA ID: 1E0C82540745	Ramp Type: PerpDiag	Initial Pass/Fail: Fail	Overall Compliance: No
Severity Score: 13.75			
Codes/Mitigation Info/Possible Solution		Field Measurements/Component Compliance

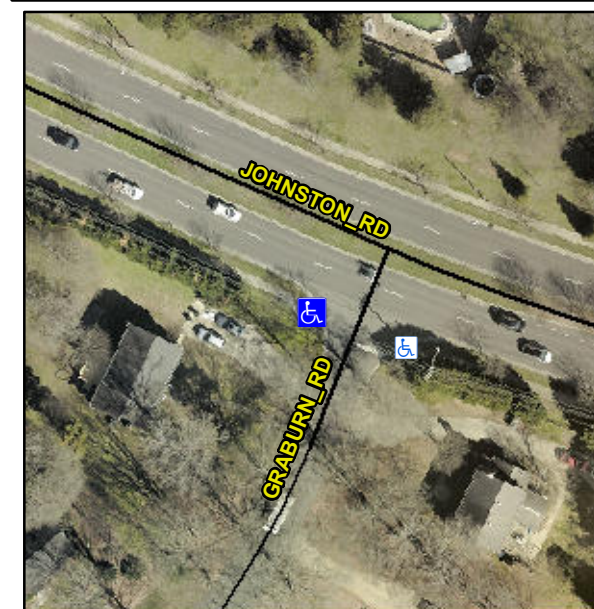
Not Found, R304.2.2, R304.5.3

Compliance	Description	Data	Compliance	Description	Data
N/A	Ramp Length (in)	59.0	No	Ramp Slope (%)	8.6
Yes	Ramp Width (in)	58.0	No	Ramp XSlope (%)	3.0
N/A	Flare Type LT	N/A	N/A	Flare Type RT	N/A
N/A	Flare Slope LT (%)	N/A	N/A	Flare Slope RT (%)	N/A
N/A	Flare Traversable LT?	N/A	N/A	Flare Traversable RT?	N/A
N/A	Landing Length (in)	N/A	N/A	DWS Provided?	N/A
N/A	Landing Width (in)	N/A	N/A	DWS Contrast?	N/A
N/A	Landing Slope (%)	N/A	N/A	DWS Length (in)	N/A
N/A	Landing X Slope (%)	N/A	N/A	DWS Full Width?	N/A
N/A	Landing Curb? (Y/N)	N/A	N/A	DWS Offset (in)	N/A
N/A	Shared Landing?	N/A			
N/A	Gutter Ponding?	N/A	N/A	Gutter Slope (%)	N/A
N/A	Gutter Lip Ht (in)	N/A	N/A	Gutter X Slope (%)	N/A
N/A	Painted X Walk1?	No	N/A	Painted X Walk2?	No
	X Walk 1 Direction	To SE		X Walk 2 Direction	To NE
N/A	X Walk 1 Width (in)	N/A	N/A	X Walk 2 Width (in)	N/A
	X Walk 1 Slope (%)	0.8		X Walk 2 Slope (%)	3.2
	X Walk 1 X Slope (%)	5.1		X Walk 2 X Slope (%)	1.3

N/A	Ramp inside XWalk1?	N/A	N/A	Ramp inside XWalk2?	N/A
	Road Slope (%)	3.0	N/A	Clear Space?	N/A
	Road X Slope (%)	4.1	N/A	Clear Space to XWalk (in)	N/A
N/A	Any Obstructions?	N/A	N/A	Storm Grate/Utility Hazard?	N/A
	Obstruction Type			Storm Grate/Utility Type	
		N/A			N/A
			Yes	Surface Condition? (G/P)	Good

Possible Solutions:

Remove & Replace Curb Ramp With Two New Directional Ramps or Equivalent.
