Access Compliance Report

Public Rights-of-Way

(Curb Ramps)

Intersection ID: 12524	Main Street: W_1ST_ST	Cross Street: S_CHURCH_ST	Location: W
ADA ID: 1E138508FB54	Ramp Type: BlendTrans1	Initial Pass/Fail: Fail	Overall Compliance: No
Severity Score: 25			
Codes/Mitigation Info/Possible Solution		Field Measurements/Component Compliance

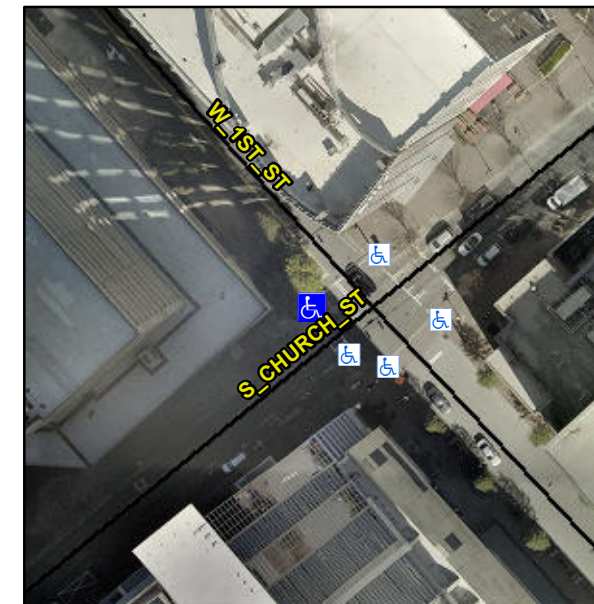
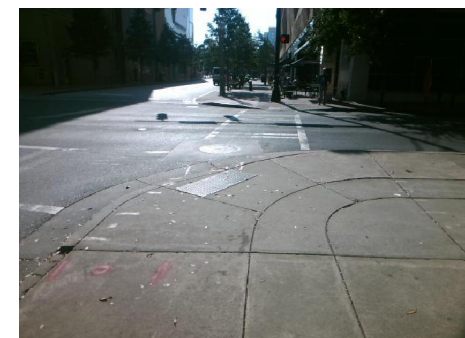
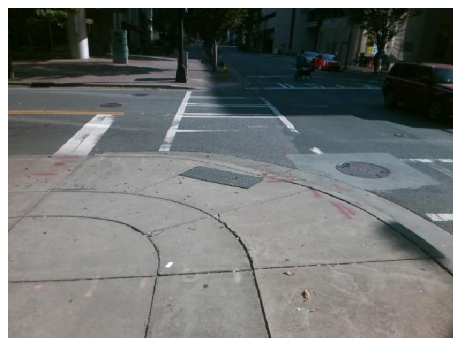
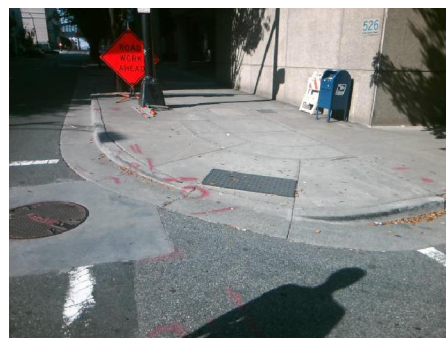
Not Found, R304.5.3

Compliance	Description	Data	Compliance	Description	Data
N/A	Ramp Length (in)	66.0	Yes	BlendTrans Slope (%)	3.2
Yes	Ramp Width (in)	48.0	No	BlendTrans XSlope (%)	9.0
N/A	Flare Type LT	N/A	N/A	Flare Type RT	N/A
N/A	Flare Slope LT (%)	N/A	N/A	Flare Slope RT (%)	N/A
N/A	Flare Traversable LT?	N/A	N/A	Flare Traversable RT?	N/A
N/A	Landing Length (in)	N/A	N/A	DWS Provided?	N/A
N/A	Landing Width (in)	N/A	N/A	DWS Contrast?	N/A
N/A	Landing Slope (%)	N/A	N/A	DWS Length (in)	N/A
N/A	Landing X Slope (%)	N/A	N/A	DWS Full Width?	N/A
N/A	Landing Curb? (Y/N)	N/A	N/A	DWS Offset (in)	N/A
N/A	Shared Landing?	N/A			
N/A	Gutter Ponding?	N/A	N/A	Gutter Slope (%)	N/A
N/A	Gutter Lip Ht (in)	N/A	N/A	Gutter X Slope (%)	N/A
N/A	Painted X Walk1?	Yes	N/A	Painted X Walk2?	Yes
	X Walk 1 Direction	To SE		X Walk 2 Direction	To NE
	X Walk 1 Width (in)	86.0		X Walk 2 Width (in)	113.0
	X Walk 1 Slope (%)	1.5		X Walk 2 Slope (%)	0.5
	X Walk 1 X Slope (%)	1.0		X Walk 2 X Slope (%)	4.4

N/A	Ramp inside XWalk1?	Yes	N/A	Ramp inside XWalk2?	Yes
	Road Slope (%)	5.3		Clear Space?	N/A
	Road X Slope (%)	0.8	N/A	Clear Space to XWalk (in)	N/A
N/A	Any Obstructions?	N/A	N/A	Storm Grate/Utility Hazard?	N/A
	Obstruction Type			Storm Grate/Utility Type	
		N/A			N/A
		Yes		Surface Condition? (G/P)	Good
		No		Curb Slope (%)	9.2

Possible Solutions:

Remove & Replace Curb Ramp With Two New Directional Ramps or Equivalent.
