Access Compliance Report Public Rights-of-Way (Curb Ramps)

Intersection ID: 5066 Main Street: IBM_DR Cross Street: OLD_MALLARD_CREEK_RD Location: NW

ADA ID: 1E1CB82C1388 Ramp Type: Perp Initial Pass/Fail: Fail Overall Compliance: No Severity Score: 48.75

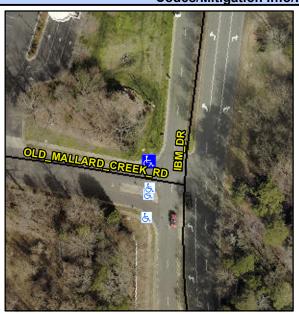
Field Measurements/Component Compliance								
Comp	liance Description	Data	Comp	liance	Description	Data		
N/A	Ramp Length (in)	48.0	No	Ramp	Slope (%)	12.5		
No	Ramp Width (in)	46.0	Yes	Ramp	XSlope (%)	0.2		
N/A	Flare Type LT	N/A	N/A	Flare	Type RT	N/A		
N/A	Flare Slope LT (%)	N/A	N/A	Flare	Slope RT (%)	N/A		
N/A	Flare Traversable LT?	N/A	N/A	Flare	Traversable RT?	N/A		
N/A	Landing Length (in)	N/A	N/A	DWS	Provided?	N/A		
N/A	Landing Width (in)	N/A	N/A	DWS	Contrast?	N/A		
N/A	Landing Slope (%)	N/A	N/A	DWS	Length (in)	N/A		
N/A	Landing X Slope (%)	N/A	N/A	DWS	Full Width?	N/A		
N/A	Landing Curb? (Y/N)	N/A	N/A	DWS	Offset (in)	N/A		
N/A	Shared Landing?	N/A						
N/A	Gutter Ponding?	N/A	N/A	Gutte	r Slope (%)	N/A		
N/A	Gutter Lip Ht (in)	N/A	N/A	Gutte	r X Slope (%)	N/A		
N/A	Painted X Walk1?	No	N/A	Paint	ed X Walk2?	N/A		
	X Walk 1 Direction	To S		X Wa	lk 2 Direction	N/A		
N/A	X Walk 1 Width (in)	N/A	N/A	X Wa	lk 2 Width (in)	N/A

X Walk 1 Slope (%)	0.3		X Wa	lk 2 Slope (%)	N/A		
	X Walk 1 X Slope (%)	5.8		X Wa	lk 2 X Slope (%)	N/A		
N/A	Ramp inside XWalk1?	N/A	N/A	Ramp	inside XWalk2?	N/A		
	Road Slope (%)	N/A	N/A	Clear	Space?	N/A		
	Road X Slope (%)	N/A	N/A	Clear	Space to XWalk (in)	N/A		
N/A	Any Obstructions?	N/A	N/A	Storm	n Grate/Utility Hazard?	N/A		
	Obstruction Type			Storm	Grate/Utility Type			
		N/A				N/A		
			No	Surfa	ce Condition? (G/P)	Poor

Possible Solutions:	9
Remove & Replace Entire Ramp.	
	N
	N
	N
	N
	N
Surveyor Notes:	N
N/A	N
	N
	N
	N
PROW/ADA:	N
Not Found, R304.5.1, R304.2.2,	N
R302.7	N
	N
	N

1850.00
