# Access Compliance Report

## Public Rights-of-Way

| Intersection ID: 46725 | Main Street: FAWN_VIEW_DR | Cross Street: HAMILTON_FOREST_DR | Location: W |
| ADA ID: 1E1EEA514446 | Ramp Type: PerpDiag | Initial Pass/Fail: Fail | Overall Compliance: No |

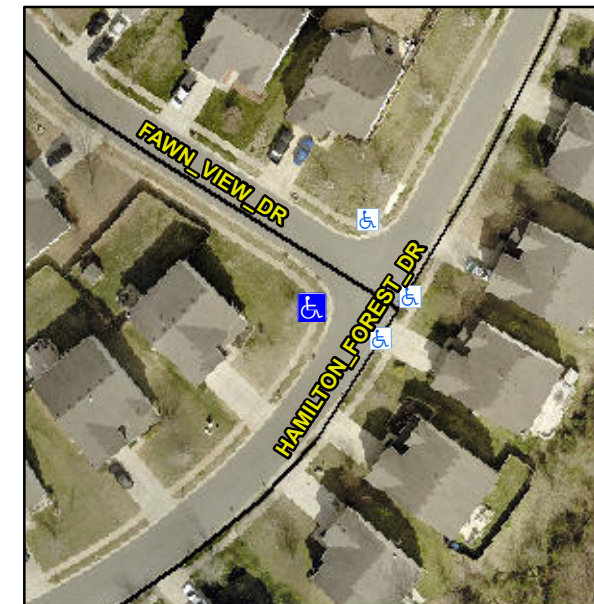
| Severity Score: 17.5 | | | |

**Not Found, R304.5.1**

| Compliance | Description | Data | Compliance | Description | Data |
|---|---|---|---|---|---|
| N/A | Ramp Length (in) | 46.5 | Yes | Ramp Slope (%) | 8.0 |
| No | Ramp Width (in) | 33.0 | Yes | Ramp XSlope (%) | 0.3 |

**Remove & Replace Curb Ramp With Two New Directional Ramps or Equivalent.**

Total Cost: \$ 3200.00
