Access Compliance Report

Public Rights-of-Way

(Curb Ramps)

Intersection ID: 10029825	Main Street: KREFELD_DR	Cross Street: N/A	Location: SW
ADA ID: 1E21CA529090	Ramp Type: PerpDiag	Initial Pass/Fail: Fail	Overall Compliance: No
		Severity Score: 30

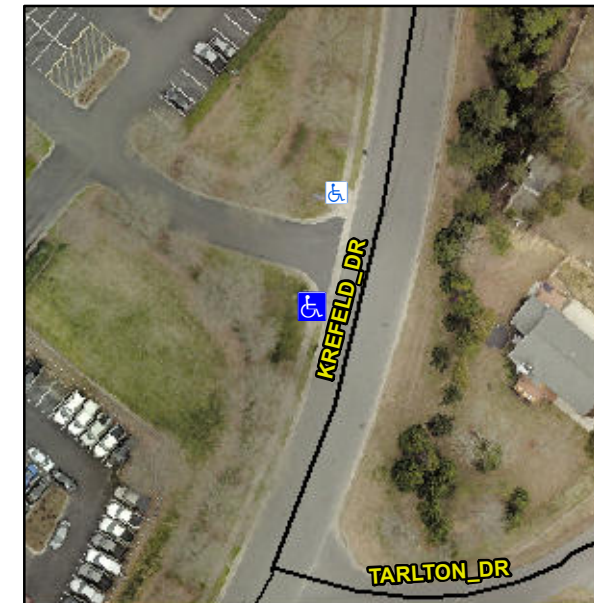
Not Found, R304.5.1, R304.2.2

Compliance	Description	Data	Compliance	Description	Data
N/A	Ramp Length (in)	95.0	No	Ramp Slope (%)	10.2
No	Ramp Width (in)	32.0	Yes	Ramp XSlope (%)	1.4
N/A	Flare Type LT	N/A	N/A	Flare Type RT	N/A
N/A	Flare Slope LT (%)	N/A	N/A	Flare Slope RT (%)	N/A
N/A	Flare Traversable LT?	N/A	N/A	Flare Traversable RT?	N/A
N/A	Landing Length (in)	N/A	N/A	DWS Provided?	N/A
N/A	Landing Width (in)	N/A	N/A	DWS Contrast?	N/A
N/A	Landing Slope (%)	N/A	N/A	DWS Length (in)	N/A
N/A	Landing X Slope (%)	N/A	N/A	DWS Full Width?	N/A
N/A	Landing Curb? (Y/N)	N/A	N/A	DWS Offset (in)	N/A
N/A	Shared Landing?	N/A			
N/A	Gutter Ponding?	N/A	N/A	Gutter Slope (%)	N/A
N/A	Gutter Lip Ht (in)	N/A	N/A	Gutter X Slope (%)	N/A
N/A	Painted X Walk1?	No	N/A	Painted X Walk2?	No
	X Walk 1 Direction	To E		X Walk 2 Direction	To N
N/A	X Walk 1 Width (in)	N/A	N/A	X Walk 2 Width (in)	N/A
	X Walk 1 Slope (%)	2.4		X Walk 2 Slope (%)	0.9
	X Walk 1 X Slope (%)	0.9		X Walk 2 X Slope (%)	5.7

N/A	Ramp inside XWalk1?	N/A	N/A	Ramp inside XWalk2?	N/A
	Road Slope (%)	0.1	N/A	Clear Space?	N/A
	Road X Slope (%)	5.0	N/A	Clear Space to XWalk (in)	N/A
N/A	Any Obstructions?	N/A	N/A	Storm Grate/Utility Hazard?	N/A
	Obstruction Type			Storm Grate/Utility Type	
		N/A			N/A
			Yes	Surface Condition? (G/P)	Good

Possible Solutions:

Remove & Replace Curb Ramp With Two New Directional Ramps or Equivalent.
