Access Compliance Report

Public Rights-of-Way

(Curb Ramps)

Intersection ID: 10745	Main Street: E_35TH_ST	Cross Street: HOLT_ST	Location: E
ADA ID: 1E2F9F683E0B	Ramp Type: Perp	Initial Pass/Fail: Fail	Overall Compliance: No
Severity Score: 12.5			
Codes/Mitigation Info/Possible Solution		Field Measurements/Component Compliance

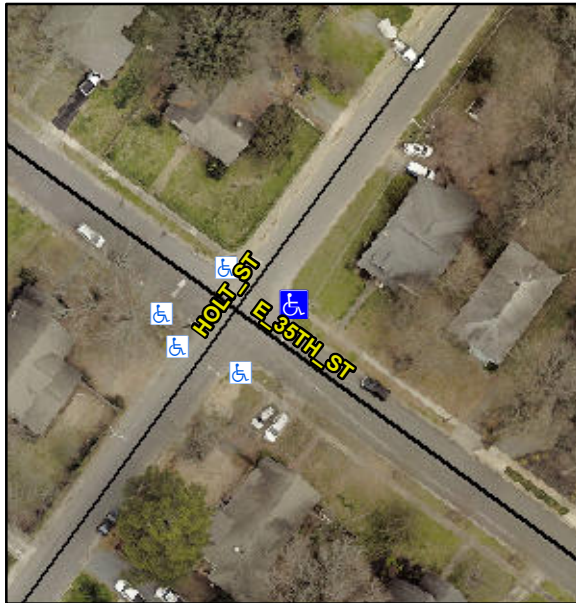
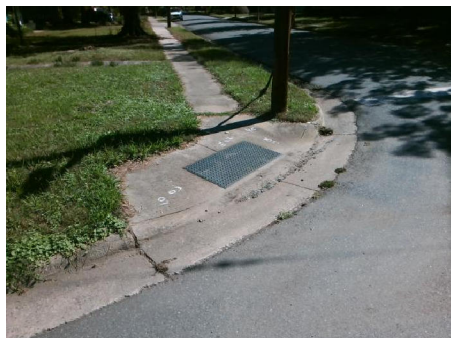
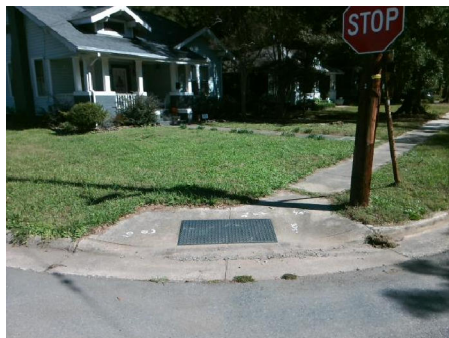
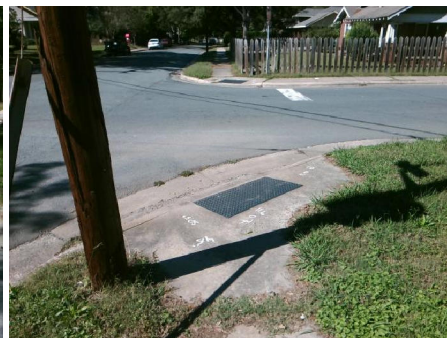
Not Found, R304.2.2

Compliance	Description	Data	Compliance	Description	Data
N/A	Ramp Length (in)	50.5	No	Ramp Slope (%)	11.6
Yes	Ramp Width (in)	48.0	Yes	Ramp XSlope (%)	0.7
N/A	Flare Type LT	N/A	N/A	Flare Type RT	N/A
N/A	Flare Slope LT (%)	N/A	N/A	Flare Slope RT (%)	N/A
N/A	Flare Traversable LT?	N/A	N/A	Flare Traversable RT?	N/A
N/A	Landing Length (in)	N/A	N/A	DWS Provided?	N/A
N/A	Landing Width (in)	N/A	N/A	DWS Contrast?	N/A
N/A	Landing Slope (%)	N/A	N/A	DWS Length (in)	N/A
N/A	Landing X Slope (%)	N/A	N/A	DWS Full Width?	N/A
N/A	Landing Curb? (Y/N)	N/A	N/A	DWS Offset (in)	N/A
N/A	Shared Landing?	N/A			
N/A	Gutter Ponding?	N/A	N/A	Gutter Slope (%)	N/A
N/A	Gutter Lip Ht (in)	N/A	N/A	Gutter X Slope (%)	N/A
N/A	Painted X Walk1?	No	N/A	Painted X Walk2?	N/A
	X Walk 1 Direction	To NW		X Walk 2 Direction	N/A
N/A	X Walk 1 Width (in)	N/A	N/A	X Walk 2 Width (in)	N/A
	X Walk 1 Slope (%)	1.0		X Walk 2 Slope (%)	N/A
	X Walk 1 X Slope (%)	0.3		X Walk 2 X Slope (%)	N/A

N/A	Ramp inside XWalk1?	N/A	N/A	Ramp inside XWalk2?	N/A
	Road Slope (%)	N/A	N/A	Clear Space?	N/A
	Road X Slope (%)	N/A	N/A	Clear Space to XWalk (in)	N/A
N/A	Any Obstructions?	N/A	N/A	Storm Grate/Utility Hazard?	N/A
	Obstruction Type			Storm Grate/Utility Type	
		N/A			N/A
			Yes	Surface Condition? (G/P)	Good

Possible Solutions:

Remove & Replace Entire Ramp.
