Access Compliance Report

Public Rights-of-Way

(Curb Ramps)

Intersection ID: 25717	Main Street: WOODLEIGH_OAKS_DR	Cross Street: WOODMERE_CROSSING_LN	Location: SW
ADA ID: 1E39BC6A6887	Ramp Type: Perp	Initial Pass/Fail: Fail	Overall Compliance: No
			Severity Score: 10

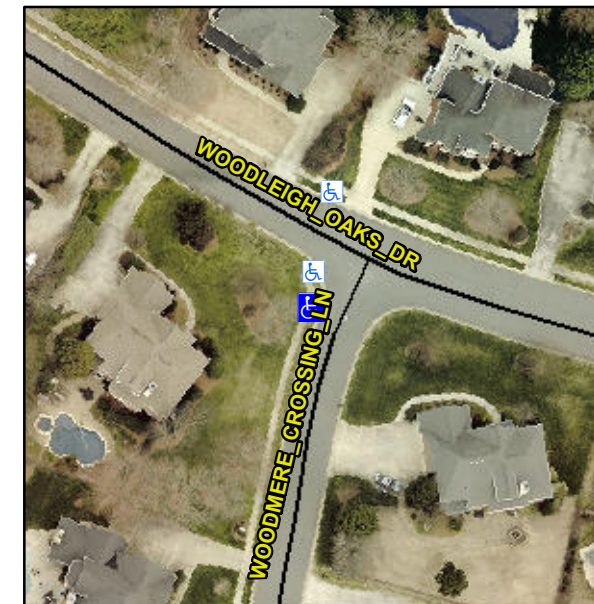
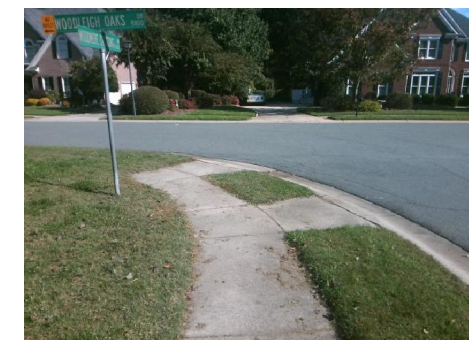
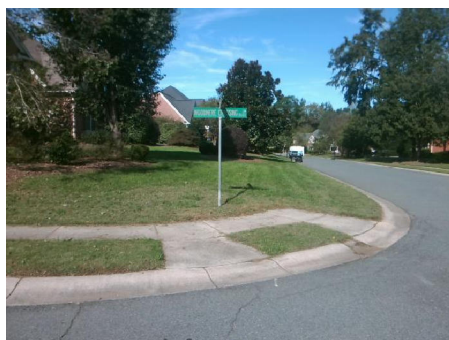
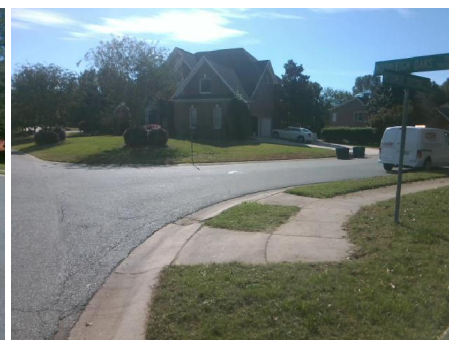
Compliance	Description	Data	Compliance	Description	Data
N/A	Ramp Length (in)	92.0	Yes	Ramp Slope (%)	6.2
No	Ramp Width (in)	37.0	No	Ramp XSlope (%)	3.9
N/A	Flare Type LT	N/A	N/A	Flare Type RT	N/A
N/A	Flare Slope LT (%)	N/A	N/A	Flare Slope RT (%)	N/A
N/A	Flare Traversable LT?	N/A	N/A	Flare Traversable RT?	N/A
N/A	Landing Length (in)	N/A	N/A	DWS Provided?	N/A
N/A	Landing Width (in)	N/A	N/A	DWS Contrast?	N/A
N/A	Landing Slope (%)	N/A	N/A	DWS Length (in)	N/A
N/A	Landing X Slope (%)	N/A	N/A	DWS Full Width?	N/A
N/A	Landing Curb? (Y/N)	N/A	N/A	DWS Offset (in)	N/A
N/A	Shared Landing?	N/A			
N/A	Gutter Ponding?	N/A	N/A	Gutter Slope (%)	N/A
N/A	Gutter Lip Ht (in)	N/A	N/A	Gutter X Slope (%)	N/A
N/A	Painted X Walk1?	No	N/A	Painted X Walk2?	N/A
	X Walk 1 Direction	To SE		X Walk 2 Direction	N/A
N/A	X Walk 1 Width (in)	N/A	N/A	X Walk 2 Width (in)	N/A
	X Walk 1 Slope (%)	0.6		X Walk 2 Slope (%)	N/A
	X Walk 1 X Slope (%)	0.2		X Walk 2 X Slope (%)	N/A

N/A	Ramp inside XWalk1?	N/A	N/A	Ramp inside XWalk2?	N/A
	Road Slope (%)	N/A	N/A	Clear Space?	N/A
	Road X Slope (%)	N/A	N/A	Clear Space to XWalk (in)	N/A
N/A	Any Obstructions?	N/A	N/A	Storm Grate/Utility Hazard?	N/A
	Obstruction Type			Storm Grate/Utility Type	
		N/A			N/A
			Yes	Surface Condition? (G/P)	Good

Remove & Replace Entire Ramp.
