# Access Compliance Report

## Public Rights-of-Way

### (Curb Ramps)

Intersection ID: N/A	Main Street: 3RD_ST	Cross Street: JOHN_BELK_FY	Location: N
ADA ID: 1E616EF32324	Ramp Type: Directional1	Initial Pass/Fail: Pass	Overall Compliance: No
		Severity Score: 0

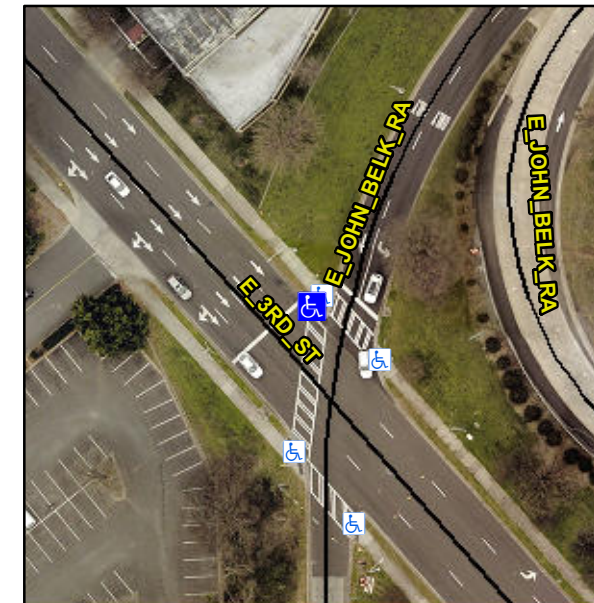
**R304.2.2-Perp, R304.3.2-Para,  
R305.2**

Compliance	Description	Data	Compliance	Description	Data
N/A	Ramp Length (in)	70.0	Yes	Grade Break?	Yes
Yes	Ramp Width (in)	92.0	Yes	Grade Break Slope (%)	0.8
Yes	Ramp Slope (%)	4.9	Yes	Grade Break XSlope (%)	0.4
Yes	Ramp XSlope (%)	1.2			
N/A	Flare Type LT	N/A	N/A	Flare Type RT	N/A
N/A	Flare Slope LT (%)	N/A	N/A	Flare Slope RT (%)	N/A
N/A	Flare Traversable LT?	N/A	N/A	Flare Traversable RT?	N/A
Yes	Landing Length (in)	61.0	Yes	DWS Provided?	Yes
Yes	Landing Width (in)	92.7	Yes	DWS Contrast?	Yes
No	Landing Slope (%)	4.5	Yes	DWS Length (in)	24.0
Yes	Landing X Slope (%)	0.3	Yes	DWS Full Width?	Yes
N/A	Landing Curb? (Y/N)	N/A	No	DWS Offset LT (in)	2.5
N/A	Shared Landing?	No	Yes	DWS Offset RT (in)	2.5
Yes	Gutter Ponding?	No	Yes	Gutter Slope (%)	0.2
Yes	Gutter Lip Ht (in)	0.0	Yes	Gutter X Slope (%)	0.4
N/A	Painted X Walk1?	Yes		Road Slope (%)	2.5
	X Walk 1 Direction	To SE		Road X Slope (%)	0.6
	X Walk 1 Width (in)	126.0		Clear Space?	Yes

X Walk 1 Slope (%)	2.5	N/A	Clear Space to XWalk (in)	N/A
	X Walk 1 X Slope (%)	0.6	Yes	Storm Grate/Utility Hazard?	No
Yes	Ramp inside XWalk1?	Yes		Storm Grate/Utility Type	
Yes	Any Obstructions?	No			N/A
	Obstruction Type		Yes	Surface Condition? (G/P)	Good
			N/A	Curb Slope (%)	6.9

**Remove & Replace Entire Ramp.**
