# Access Compliance Report

## Public Rights-of-Way

### (Curb Ramps)

Intersection ID: 13388	Main Street: S_CHURCH_ST	Cross Street: W_SUMMIT_AV	Location: SE
ADA ID: 1E627FD517E5	Ramp Type: Perp	Initial Pass/Fail: Fail	Overall Compliance: No
Severity Score: 1.25			
Codes/Mitigation Info/Possible Solution		Field Measurements/Component Compliance

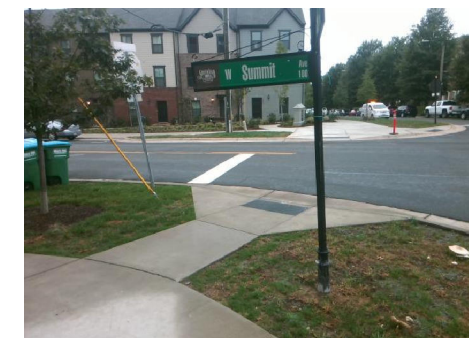
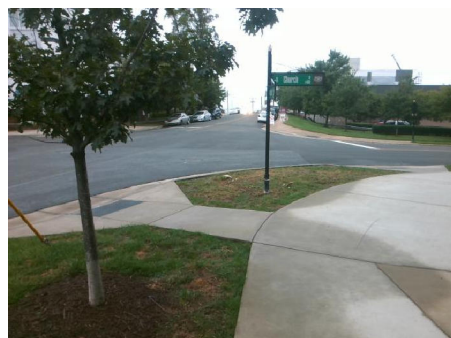
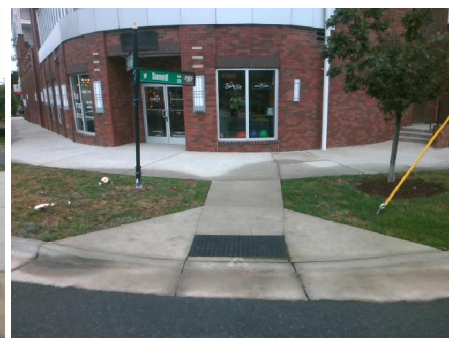
Compliance	Description	Data	Compliance	Description	Data
N/A	Ramp Length (in)	73.5	Yes	Ramp Slope (%)	6.1
Yes	Ramp Width (in)	52.5	No	Ramp XSlope (%)	2.3
N/A	Flare Type LT	N/A	N/A	Flare Type RT	N/A
N/A	Flare Slope LT (%)	N/A	N/A	Flare Slope RT (%)	N/A
N/A	Flare Traversable LT?	N/A	N/A	Flare Traversable RT?	N/A
N/A	Landing Length (in)	N/A	N/A	DWS Provided?	N/A
N/A	Landing Width (in)	N/A	N/A	DWS Contrast?	N/A
N/A	Landing Slope (%)	N/A	N/A	DWS Length (in)	N/A
N/A	Landing X Slope (%)	N/A	N/A	DWS Full Width?	N/A
N/A	Landing Curb? (Y/N)	N/A	N/A	DWS Offset (in)	N/A
N/A	Shared Landing?	N/A			
N/A	Gutter Ponding?	N/A	N/A	Gutter Slope (%)	N/A
N/A	Gutter Lip Ht (in)	N/A	N/A	Gutter X Slope (%)	N/A
N/A	Painted X Walk1?	No	N/A	Painted X Walk2?	N/A
	X Walk 1 Direction	To SW		X Walk 2 Direction	N/A
N/A	X Walk 1 Width (in)	N/A	N/A	X Walk 2 Width (in)	N/A
	X Walk 1 Slope (%)	2.2		X Walk 2 Slope (%)	N/A
	X Walk 1 X Slope (%)	3.1		X Walk 2 X Slope (%)	N/A

N/A	Ramp inside XWalk1?	N/A	N/A	Ramp inside XWalk2?	N/A
	Road Slope (%)	N/A	N/A	Clear Space?	N/A
	Road X Slope (%)	N/A	N/A	Clear Space to XWalk (in)	N/A
N/A	Any Obstructions?	N/A	N/A	Storm Grate/Utility Hazard?	N/A
	Obstruction Type			Storm Grate/Utility Type	
		N/A			N/A
		Yes		Surface Condition? (G/P)	Good

Possible Solutions:

**Remove & Replace Entire Ramp.**

**R304.5.3**

**\$ 1850.00**
