Access Compliance Report

Public Rights-of-Way

(Curb Ramps)

Intersection ID: 10025647	Main Street: EAGLEWIND_DR	Cross Street: N/A	Location: E
ADA ID: 1E63261D8CD9	Ramp Type: PerpDiag	Initial Pass/Fail: Fail	Overall Compliance: No
		Severity Score: 8.75

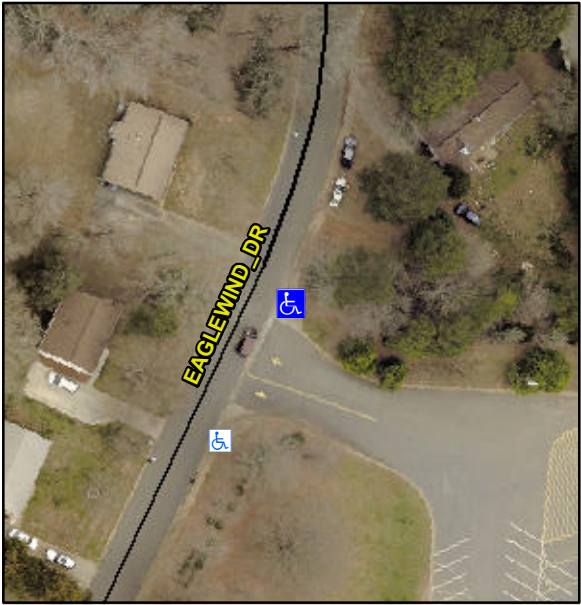
Possible Solutions:		Compliance	Description	Data
	Remove & Replace Curb Ramp With Two New Directional Ramps or Equivalent.		N/A	Ramp Length (in)	48.0
			No	Ramp Width (in)	44.0
			N/A	Flare Type LT	N/A
			N/A	Flare Slope LT (%)	N/A
			N/A	Flare Traversable LT?	N/A
			N/A	Landing Length (in)	N/A
			N/A	Landing Width (in)	N/A
			N/A	Landing Slope (%)	N/A
			N/A	Landing X Slope (%)	N/A
<p>Surveyor Notes:</p> <p>N/A</p> <p>PROW/ADA:</p> <p>R304.5.1</p>			N/A	Flare Type RT	N/A
			N/A	Flare Slope RT (%)	N/A
			N/A	Flare Traversable RT?	N/A
			N/A	DWS Provided?	N/A
			N/A	DWS Contrast?	N/A
			N/A	DWS Length (in)	N/A
			N/A	DWS Full Width?	N/A
			N/A	DWS Offset (in)	N/A
			N/A	Gutter Ponding?	N/A
			N/A	Gutter Lip Ht (in)	N/A
			No	Painted X Walk1?	No
				X Walk 1 Direction	To NW
			N/A	X Walk 1 Width (in)	N/A
				X Walk 1 Slope (%)	1.1

X Walk 1 X Slope (%)	0.7
			N/A	Ramp inside XWalk1?	N/A
				Road Slope (%)	3.7
				Road X Slope (%)	1.8
			N/A	Any Obstructions?	N/A
				Obstruction Type	
Total Cost:			\$	3200.00	
					N/A
			N/A	Surface Condition? (G/P)	Good
