Access Compliance Report

Public Rights-of-Way

(Curb Ramps)

Intersection ID: 18844	Main Street: NATIONS_FORD_RD	Cross Street: TYVOLA_RD	Location: NE
ADA ID: 1E6F941A9A80	Ramp Type: Perp	Initial Pass/Fail: Fail	Overall Compliance: No
		Severity Score: 12.5

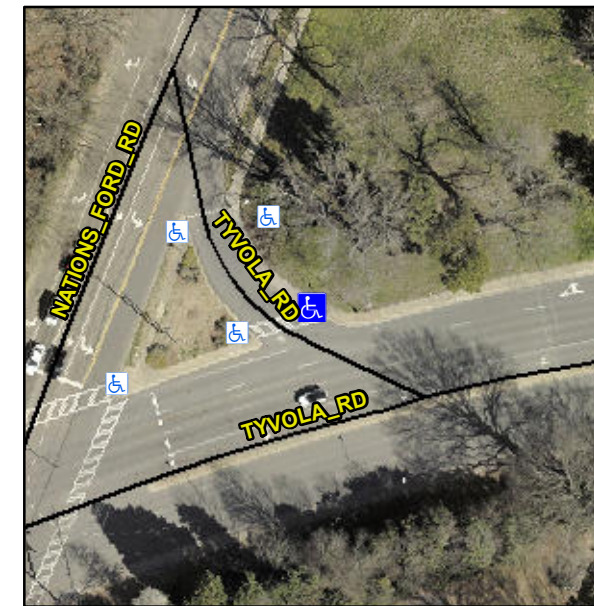
Not Found, R304.2.2

Compliance	Description	Data	Compliance	Description	Data
N/A	Ramp Length (in)	60.0	No	Ramp Slope (%)	8.5
Yes	Ramp Width (in)	48.0	Yes	Ramp XSlope (%)	0.2
N/A	Flare Type LT	N/A	N/A	Flare Type RT	N/A
N/A	Flare Slope LT (%)	N/A	N/A	Flare Slope RT (%)	N/A
N/A	Flare Traversable LT?	N/A	N/A	Flare Traversable RT?	N/A
N/A	Landing Length (in)	N/A	N/A	DWS Provided?	N/A
N/A	Landing Width (in)	N/A	N/A	DWS Contrast?	N/A
N/A	Landing Slope (%)	N/A	N/A	DWS Length (in)	N/A
N/A	Landing X Slope (%)	N/A	N/A	DWS Full Width?	N/A
N/A	Landing Curb? (Y/N)	N/A	N/A	DWS Offset (in)	N/A
N/A	Shared Landing?	N/A			
N/A	Gutter Ponding?	N/A	N/A	Gutter Slope (%)	N/A
N/A	Gutter Lip Ht (in)	N/A	N/A	Gutter X Slope (%)	N/A
N/A	Painted X Walk1?	Yes	N/A	Painted X Walk2?	N/A
	X Walk 1 Direction	To W		X Walk 2 Direction	N/A
N/A	X Walk 1 Width (in)	78.0	N/A	X Walk 2 Width (in)	N/A
	X Walk 1 Slope (%)	1.8		X Walk 2 Slope (%)	N/A
	X Walk 1 X Slope (%)	1.1		X Walk 2 X Slope (%)	N/A

N/A	Ramp inside XWalk1?	Yes	N/A	Ramp inside XWalk2?	N/A
	Road Slope (%)	N/A	N/A	Clear Space?	N/A
	Road X Slope (%)	N/A	N/A	Clear Space to XWalk (in)	N/A
N/A	Any Obstructions?	N/A	N/A	Storm Grate/Utility Hazard?	N/A
	Obstruction Type			Storm Grate/Utility Type	
		N/A			N/A
			Yes	Surface Condition? (G/P)	Good

Remove & Replace Entire Ramp.
