Access Compliance Report

Public Rights-of-Way

(Curb Ramps)

Intersection ID: 27900	Main Street: FROHOCK_PL	Cross Street: HARRISON'S_CROSSING_AV	Location: S
ADA ID: 1E887C8D9853	Ramp Type: BlendTrans2	Initial Pass/Fail: Fail	Overall Compliance: No
Severity Score: 25			
Codes/Mitigation Info/Possible Solution		Field Measurements/Component Compliance

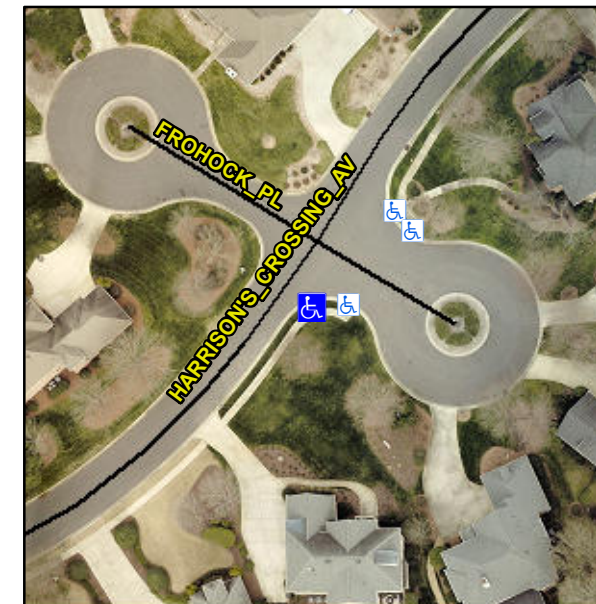
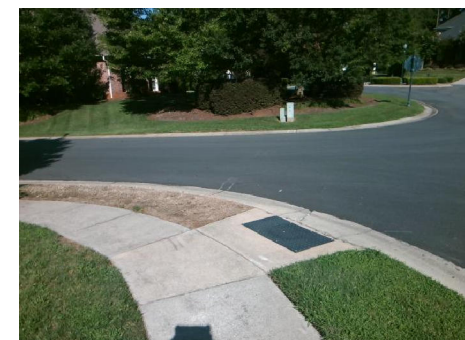
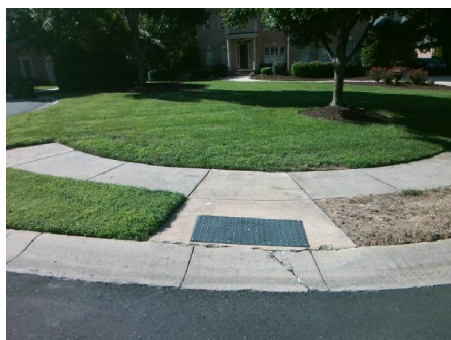
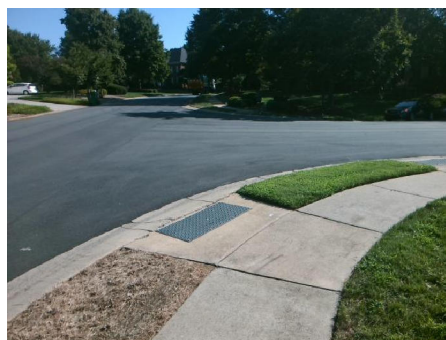
Not Found, R304.5.3

Compliance	Description	Data	Compliance	Description	Data
N/A	Ramp Length (in)	95.0	Yes	BlendTrans Slope (%)	0.8
Yes	Ramp Width (in)	48.0	No	BlendTrans XSlope (%)	9.7
N/A	Flare Type LT	N/A	N/A	Flare Type RT	N/A
N/A	Flare Slope LT (%)	N/A	N/A	Flare Slope RT (%)	N/A
N/A	Flare Traversable LT?	N/A	N/A	Flare Traversable RT?	N/A
N/A	Landing Length (in)	N/A	N/A	DWS Provided?	N/A
N/A	Landing Width (in)	N/A	N/A	DWS Contrast?	N/A
N/A	Landing Slope (%)	N/A	N/A	DWS Length (in)	N/A
N/A	Landing X Slope (%)	N/A	N/A	DWS Full Width?	N/A
N/A	Landing Curb? (Y/N)	N/A	N/A	DWS Offset (in)	N/A
N/A	Shared Landing?	N/A			
N/A	Gutter Ponding?	N/A	N/A	Gutter Slope (%)	N/A
N/A	Gutter Lip Ht (in)	N/A	N/A	Gutter X Slope (%)	N/A
N/A	Painted X Walk1?	No	N/A	Painted X Walk2?	N/A
	X Walk 1 Direction	To NW		X Walk 2 Direction	N/A
	X Walk 1 Width (in)	N/A		X Walk 2 Width (in)	N/A
	X Walk 1 Slope (%)	0.7		X Walk 2 Slope (%)	N/A
	X Walk 1 X Slope (%)	8.7		X Walk 2 X Slope (%)	N/A

N/A	Ramp inside XWalk1?	N/A	N/A	Ramp inside XWalk2?	N/A
	Road Slope (%)	8.7		Clear Space?	N/A
	Road X Slope (%)	0.7	N/A	Clear Space to XWalk (in)	N/A
N/A	Any Obstructions?	N/A	N/A	Storm Grate/Utility Hazard?	N/A
	Obstruction Type			Storm Grate/Utility Type	
		N/A			N/A
			Yes	Surface Condition? (G/P)	Good
			No	Curb Slope (%)	9.8

Possible Solutions:

Remove & Replace Curb Ramp With Two New Directional Ramps or Equivalent.
