Access Compliance Report

Public Rights-of-Way

(Curb Ramps)

Intersection ID: 4733	Main Street: KENDALE_CT	Cross Street: TRINITY_RD	Location:	N
ADA ID: 1E8D847EA8A3	Ramp Type: Perp	Initial Pass/Fail: Fail	Overall Compliance: No	Severity Score: 1.25
Codes/Mitigation Info/Possible Solution		Field Measurements/Component Compliance

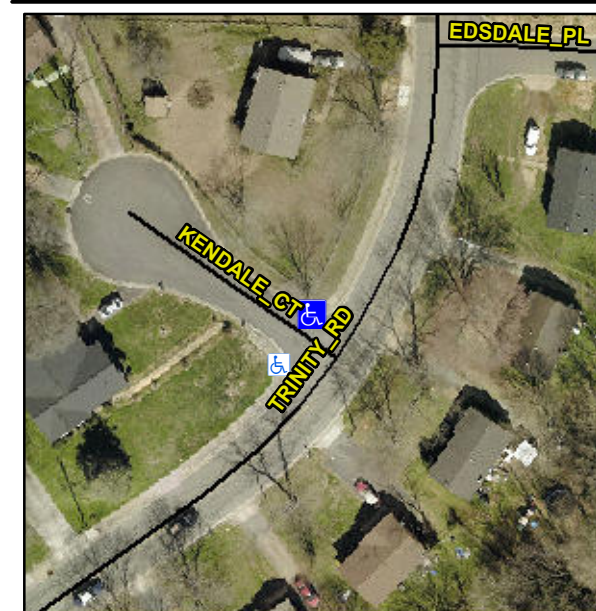
Not Found, R304.5.3

Compliance	Description	Data	Compliance	Description	Data
N/A	Ramp Length (in)	60.0	Yes	Ramp Slope (%)	5.5
Yes	Ramp Width (in)	48.0	No	Ramp XSlope (%)	3.5
N/A	Flare Type LT	N/A	N/A	Flare Type RT	N/A
N/A	Flare Slope LT (%)	N/A	N/A	Flare Slope RT (%)	N/A
N/A	Flare Traversable LT?	N/A	N/A	Flare Traversable RT?	N/A
N/A	Landing Length (in)	N/A	N/A	DWS Provided?	N/A
N/A	Landing Width (in)	N/A	N/A	DWS Contrast?	N/A
N/A	Landing Slope (%)	N/A	N/A	DWS Length (in)	N/A
N/A	Landing X Slope (%)	N/A	N/A	DWS Full Width?	N/A
N/A	Landing Curb? (Y/N)	N/A	N/A	DWS Offset (in)	N/A
N/A	Shared Landing?	N/A			
N/A	Gutter Ponding?	N/A	N/A	Gutter Slope (%)	N/A
N/A	Gutter Lip Ht (in)	N/A	N/A	Gutter X Slope (%)	N/A
N/A	Painted X Walk1?	No	N/A	Painted X Walk2?	N/A
	X Walk 1 Direction	To SW		X Walk 2 Direction	N/A
N/A	X Walk 1 Width (in)	N/A	N/A	X Walk 2 Width (in)	N/A
	X Walk 1 Slope (%)	2.8		X Walk 2 Slope (%)	N/A
	X Walk 1 X Slope (%)	2.1		X Walk 2 X Slope (%)	N/A

N/A	Ramp inside XWalk1?	N/A	N/A	Ramp inside XWalk2?	N/A
	Road Slope (%)	N/A	N/A	Clear Space?	N/A
	Road X Slope (%)	N/A	N/A	Clear Space to XWalk (in)	N/A
N/A	Any Obstructions?	N/A	N/A	Storm Grate/Utility Hazard?	N/A
	Obstruction Type			Storm Grate/Utility Type	
		N/A			N/A
			Yes	Surface Condition? (G/P)	Good

Remove & Replace Entire Ramp.

Total Cost: \$ 1850.00
