# Access Compliance Report

## Public Rights-of-Way

### (Curb Ramps)

Intersection ID: 30474	Main Street: CREEK_TURN_DR	Cross Street: GOLDEN_VIEW_DR	Location: NW
ADA ID: 1EA02DB18ACC	Ramp Type: PerpDiag	Initial Pass/Fail: Fail	Overall Compliance: No
		Severity Score: 60

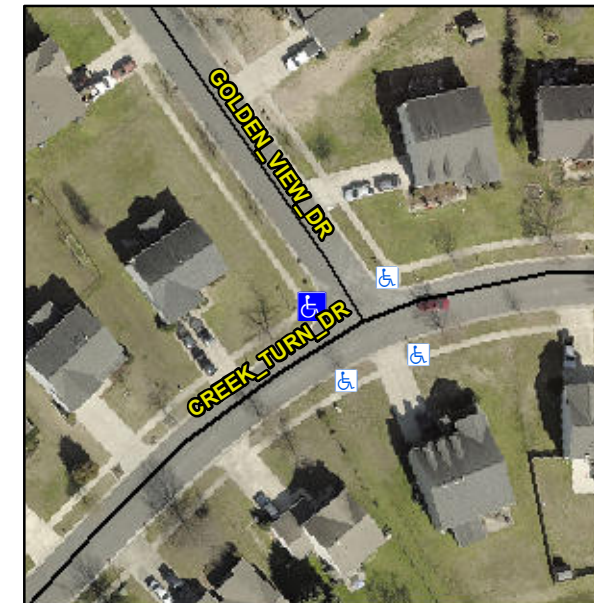
Compliance	Description	Data	Compliance	Description	Data
N/A	Ramp Length (in)	84.0	Yes	Ramp Slope (%)	7.6
No	Ramp Width (in)	30.0	No	Ramp XSlope (%)	9.1
N/A	Flare Type LT	N/A	N/A	Flare Type RT	N/A
N/A	Flare Slope LT (%)	N/A	N/A	Flare Slope RT (%)	N/A
N/A	Flare Traversable LT?	N/A	N/A	Flare Traversable RT?	N/A
N/A	Landing Length (in)	N/A	N/A	DWS Provided?	N/A
N/A	Landing Width (in)	N/A	N/A	DWS Contrast?	N/A
N/A	Landing Slope (%)	N/A	N/A	DWS Length (in)	N/A
N/A	Landing X Slope (%)	N/A	N/A	DWS Full Width?	N/A
N/A	Landing Curb? (Y/N)	N/A	N/A	DWS Offset (in)	N/A
N/A	Shared Landing?	N/A			
N/A	Gutter Ponding?	N/A	N/A	Gutter Slope (%)	N/A
N/A	Gutter Lip Ht (in)	N/A	N/A	Gutter X Slope (%)	N/A
N/A	Painted X Walk1?	No	N/A	Painted X Walk2?	No
	X Walk 1 Direction	To SE		X Walk 2 Direction	To NE
N/A	X Walk 1 Width (in)	N/A	N/A	X Walk 2 Width (in)	N/A
	X Walk 1 Slope (%)	8.0		X Walk 2 Slope (%)	2.1
	X Walk 1 X Slope (%)	1.4		X Walk 2 X Slope (%)	5.8

N/A	Ramp inside XWalk1?	N/A	N/A	Ramp inside XWalk2?	N/A
	Road Slope (%)	5.4	N/A	Clear Space?	N/A
	Road X Slope (%)	4.7	N/A	Clear Space to XWalk (in)	N/A
N/A	Any Obstructions?	N/A	N/A	Storm Grate/Utility Hazard?	N/A
	Obstruction Type			Storm Grate/Utility Type	
		N/A			N/A
			Yes	Surface Condition? (G/P)	Good

**Remove & Replace Curb Ramp With Two New Directional Ramps or Equivalent.**

**R304.5.1, R304.5.3**

Total Cost: \$ 3200.00
