Access Compliance Report

Public Rights-of-Way

(Curb Ramps)

Intersection ID: 13745	Main Street: HAWTHORNE_LN	Cross Street: PARK_DR	Location: S
ADA ID: 1EA05E0ACC8E	Ramp Type: Perp	Initial Pass/Fail: Fail	Overall Compliance: No
Severity Score: 13.75			
Codes/Mitigation Info/Possible Solution		Field Measurements/Component Compliance

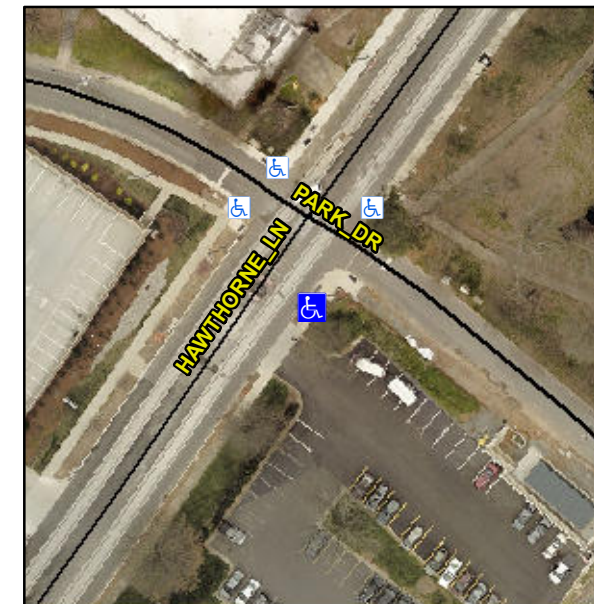
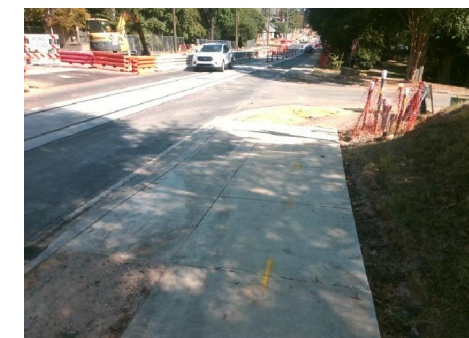
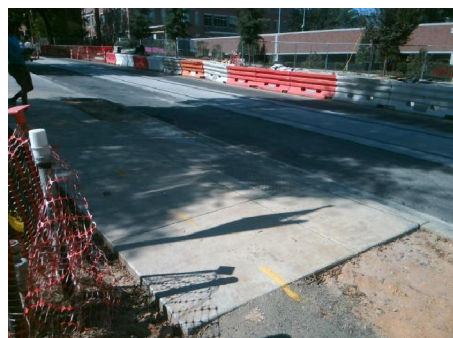
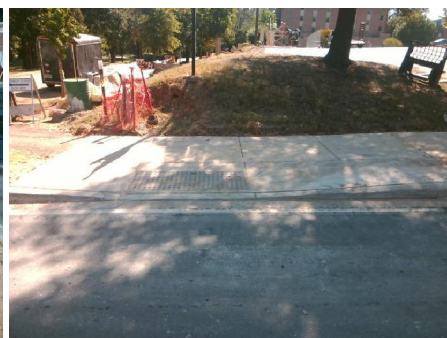
Compliance	Description	Data	Compliance	Description	Data
N/A	Ramp Length (in)	38.0	No	Ramp Slope (%)	10.6
Yes	Ramp Width (in)	59.5	No	Ramp XSlope (%)	4.7
N/A	Flare Type LT	N/A	N/A	Flare Type RT	N/A
N/A	Flare Slope LT (%)	N/A	N/A	Flare Slope RT (%)	N/A
N/A	Flare Traversable LT?	N/A	N/A	Flare Traversable RT?	N/A
N/A	Landing Length (in)	N/A	N/A	DWS Provided?	N/A
N/A	Landing Width (in)	N/A	N/A	DWS Contrast?	N/A
N/A	Landing Slope (%)	N/A	N/A	DWS Length (in)	N/A
N/A	Landing X Slope (%)	N/A	N/A	DWS Full Width?	N/A
N/A	Landing Curb? (Y/N)	N/A	N/A	DWS Offset (in)	N/A
N/A	Shared Landing?	N/A			
N/A	Gutter Ponding?	N/A	N/A	Gutter Slope (%)	N/A
N/A	Gutter Lip Ht (in)	N/A	N/A	Gutter X Slope (%)	N/A
N/A	Painted X Walk1?	No	N/A	Painted X Walk2?	N/A
	X Walk 1 Direction	To NW		X Walk 2 Direction	N/A
N/A	X Walk 1 Width (in)	N/A	N/A	X Walk 2 Width (in)	N/A
	X Walk 1 Slope (%)	0.3		X Walk 2 Slope (%)	N/A
	X Walk 1 X Slope (%)	3.7		X Walk 2 X Slope (%)	N/A

N/A	Ramp inside XWalk1?	N/A	N/A	Ramp inside XWalk2?	N/A
	Road Slope (%)	N/A	N/A	Clear Space?	N/A
	Road X Slope (%)	N/A	N/A	Clear Space to XWalk (in)	N/A
N/A	Any Obstructions?	N/A	N/A	Storm Grate/Utility Hazard?	N/A
	Obstruction Type			Storm Grate/Utility Type	
		N/A			N/A
		Yes		Surface Condition? (G/P)	Good

Possible Solutions:

Remove & Replace Entire Ramp.

R304.2.2, R304.5.3
