Access Compliance Report

Public Rights-of-Way

(Curb Ramps)

Intersection ID: 43674	Main Street: ARMOUR RIDGE DR	Cross Street: ASHETON CREEK DR	Location: S
ADA ID: 1EA47AC1CE7A	Ramp Type: PerpDiag	Initial Pass/Fail: Fail	Overall Compliance: No
Codes/Mitigation Info/Possible Solution		Field Measurements/Component Compliance

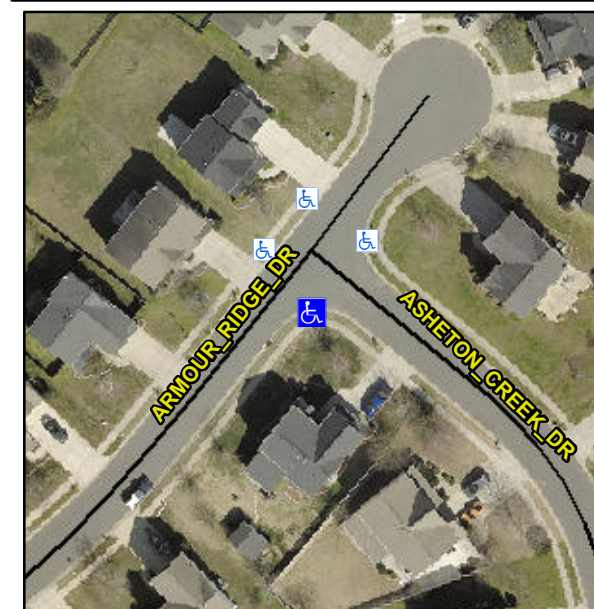
Not Found, R304.2.2, R304.5.3

Compliance	Description	Data	Compliance	Description	Data
N/A	Ramp Length (in)	46.0	No	Ramp Slope (%)	9.7
Yes	Ramp Width (in)	48.0	No	Ramp XSlope (%)	2.3
N/A	Flare Type LT	N/A	N/A	Flare Type RT	N/A
N/A	Flare Slope LT (%)	N/A	N/A	Flare Slope RT (%)	N/A
N/A	Flare Traversable LT?	N/A	N/A	Flare Traversable RT?	N/A
N/A	Landing Length (in)	N/A	N/A	DWS Provided?	N/A
N/A	Landing Width (in)	N/A	N/A	DWS Contrast?	N/A
N/A	Landing Slope (%)	N/A	N/A	DWS Length (in)	N/A
N/A	Landing X Slope (%)	N/A	N/A	DWS Full Width?	N/A
N/A	Landing Curb? (Y/N)	N/A	N/A	DWS Offset (in)	N/A
N/A	Shared Landing?	N/A			
N/A	Gutter Ponding?	N/A	N/A	Gutter Slope (%)	N/A
N/A	Gutter Lip Ht (in)	N/A	N/A	Gutter X Slope (%)	N/A
N/A	Painted X Walk1?	No	N/A	Painted X Walk2?	No
	X Walk 1 Direction	To NE		X Walk 2 Direction	To NW
N/A	X Walk 1 Width (in)	N/A	N/A	X Walk 2 Width (in)	N/A
	X Walk 1 Slope (%)	3.1		X Walk 2 Slope (%)	4.0
	X Walk 1 X Slope (%)	0.4		X Walk 2 X Slope (%)	2.4

N/A	Ramp inside XWalk1?	N/A	N/A	Ramp inside XWalk2?	N/A
	Road Slope (%)	0.7	N/A	Clear Space?	N/A
	Road X Slope (%)	3.4	N/A	Clear Space to XWalk (in)	N/A
N/A	Any Obstructions?	N/A	N/A	Storm Grate/Utility Hazard?	N/A
	Obstruction Type			Storm Grate/Utility Type	
		N/A			N/A
			Yes	Surface Condition? (G/P)	Good

Remove & Replace Curb Ramp With Two New Directional Ramps or Equivalent.
