Access Compliance Report

Public Rights-of-Way

(Curb Ramps)

| Intersection ID: 8009 | Main Street: GOSSETT_AV | Cross Street: RIDGELEY_DR | Location: W |

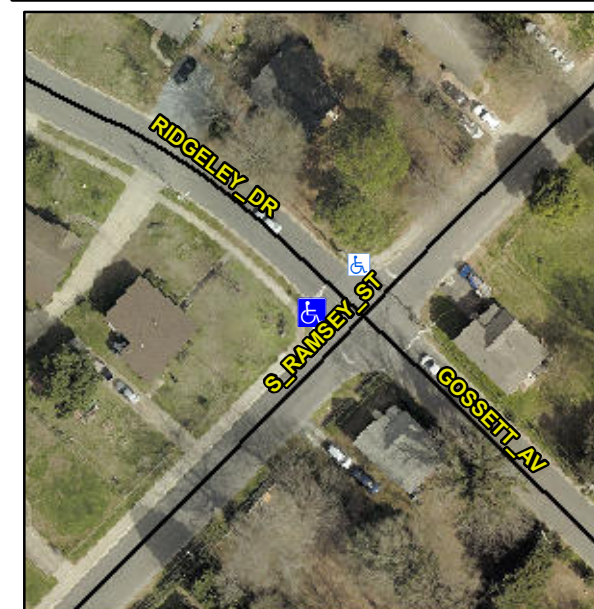
| ADA ID: 1EA6E527F780 | Ramp Type: Perp | Initial Pass/Fail: Fail | Overall Compliance: No |
| Severity Score: 12.5 | | | |

Not Found, R304.2.2

| Compliance | Description | Data | Compliance | Description | Data |
|---|---|---|---|---|---|
| N/A | Ramp Length (in) | 48.0 | No | Ramp Slope (%) | 9.4 |

Remove & Replace Entire Ramp.

Total Cost: \$ 1850.00
