## **Access Compliance Report Public Rights-of-Way** (Curb Ramps)

Intersection ID: 43101 Main Street: E\_9TH\_ST **Cross Street: PECAN AV** Location: **Overall Compliance: No** ADA ID: 1EA80E5612F6 Ramp Type: PerpDiag Initial Pass/Fail: Fail **Severity Score:** 12.5

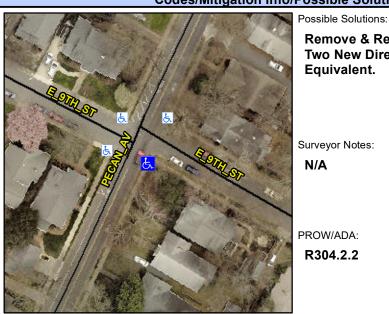
Comp	liance Description	Data	Comp	liance Description	Data
N/A	Ramp Length (in)	95.0	No	Ramp Slope (%)	10.8
Yes	Ramp Width (in)	48.0	Yes	Ramp XSlope (%)	1.8
N/A	Flare Type LT	N/A	N/A	Flare Type RT	N/A
N/A	Flare Slope LT (%)	N/A	N/A	Flare Slope RT (%)	N/A
N/A	Flare Traversable LT?	N/A	N/A	Flare Traversable RT?	N/A
N/A	Landing Length (in)	N/A	N/A	DWS Provided?	N/A
N/A	Landing Width (in)	N/A	N/A	DWS Contrast?	N/A
N/A	Landing Slope (%)	N/A	N/A	DWS Length (in)	N/A
N/A	Landing X Slope (%)	N/A	N/A	DWS Full Width?	N/A
N/A	Landing Curb? (Y/N)	N/A	N/A	DWS Offset (in)	N/A
N/A	Shared Landing?	N/A			
N/A	Gutter Ponding?	N/A	N/A	Gutter Slope (%)	N/A
N/A	Gutter Lip Ht (in)	N/A	N/A	Gutter X Slope (%)	N/A
N/A	Painted X Walk1?	No	N/A	Painted X Walk2?	No
	X Walk 1 Direction	To NE		X Walk 2 Direction	To NW
N/A	X Walk 1 Width (in)	N/A	N/A	X Walk 2 Width (in)	N/A
	X Walk 1 Slope (%)	1.0		X Walk 2 Slope (%)	4.5
	X Walk 1 X Slope (%)	0.6		X Walk 2 X Slope (%)	3.0

N/A	Ramp inside XWalk1?	N/A	N/A	Ramp inside XWalk2?	N/A
	Road Slope (%)	1.5	N/A	Clear Space?	N/A
	Road X Slope (%)	3.8	N/A	Clear Space to XWalk (in)	N/A
N/A	Any Obstructions?	N/A	N/A	Storm Grate/Utility Hazard?	N/A
	Obstruction Type		l	Storm Grate/Utility Type	
		N/A			N/A

Street 1 Name Stop Condition-Street 2 Street 2 Name Stop Condition-Street 1 Remove & Replace Curb Ramp With Two New Directional Ramps or Equivalent.

R304.2.2

> Total Cost: 3200.00
