Access Compliance Report

Public Rights-of-Way

(Curb Ramps)

Intersection ID: 14661	Main Street: E_TREMONT_AV	Cross Street: WINTHROP_AV	Location: E
ADA ID: 1EB1FAC43429	Ramp Type: Directional1	Initial Pass/Fail: Fail	Overall Compliance: No
			Severity Score: 33.75

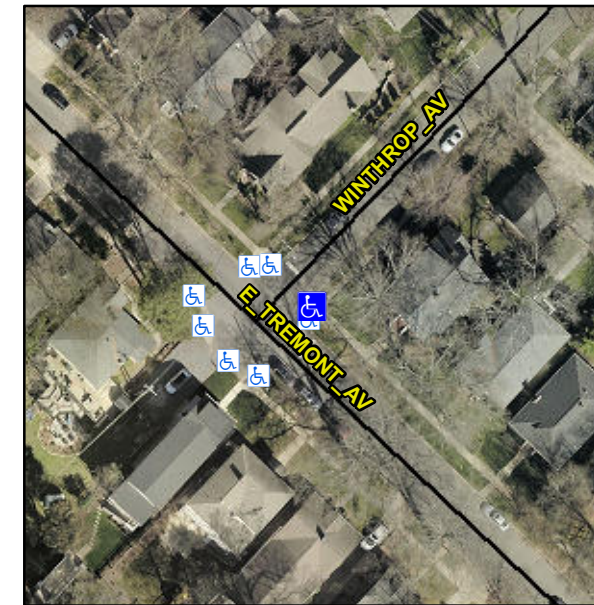
PONDING

R304.5.1, R304.5.3

Compliance	Description	Data	Compliance	Description	Data
N/A	Ramp Length (in)	208.0	N/A	Grade Break?	N/A
No	Ramp Width (in)	47.0	N/A	Grade Break Slope (%)	0.0
Yes	Ramp Slope (%)	11.8	N/A	Grade Break XSlope (%)	0.0
No	Ramp XSlope (%)	6.3			
N/A	Flare Type LT	N/A	N/A	Flare Type RT	N/A
N/A	Flare Slope LT (%)	N/A	N/A	Flare Slope RT (%)	0.0
N/A	Flare Traversable LT?	N/A	N/A	Flare Traversable RT?	N/A
N/A	Landing Length (in)	0.0	N/A	DWS Provided?	N/A
N/A	Landing Width (in)	0.0	N/A	DWS Contrast?	N/A
N/A	Landing Slope (%)	0.0	N/A	DWS Length (in)	N/A
N/A	Landing X Slope (%)	0.0	N/A	DWS Full Width?	N/A
N/A	Landing Curb? (Y/N)	N/A	N/A	DWS Offset LT (in)	N/A
N/A	Shared Landing?	N/A	N/A	DWS Offset RT (in)	N/A
N/A	Gutter Ponding?	0.0	N/A	Gutter Slope (%)	N/A
N/A	Gutter Lip Ht (in)	0.0	N/A	Gutter X Slope (%)	N/A
N/A	Painted X Walk1?	No		Road Slope (%)	1.5
	X Walk 1 Direction	To NW		Road X Slope (%)	1.9
	X Walk 1 Width (in)	N/A		Clear Space?	N/A

X Walk 1 Slope (%)	1.5	N/A	Clear Space to XWalk (in)	N/A
	X Walk 1 X Slope (%)	1.9	N/A	Storm Grate/Utility Hazard?	N/A
N/A	Ramp inside XWalk1?	N/A		Storm Grate/Utility Type	
N/A	Any Obstructions?	N/A			N/A
	Obstruction Type		Yes	Surface Condition? (G/P)	Good
			N/A	Curb Slope (%)	6.6

Remove & Replace Entire Ramp.

Total Cost: \$ 1600.00
