# Access Compliance Report

## Public Rights-of-Way

### (Curb Ramps)

Intersection ID: 10025976	Main Street: ELM_LN	Cross Street: N/A	Location: SW
ADA ID: 1EB4E1B6C420	Ramp Type: Directional1	Initial Pass/Fail: Fail	Overall Compliance: No
		Severity Score: 1.25

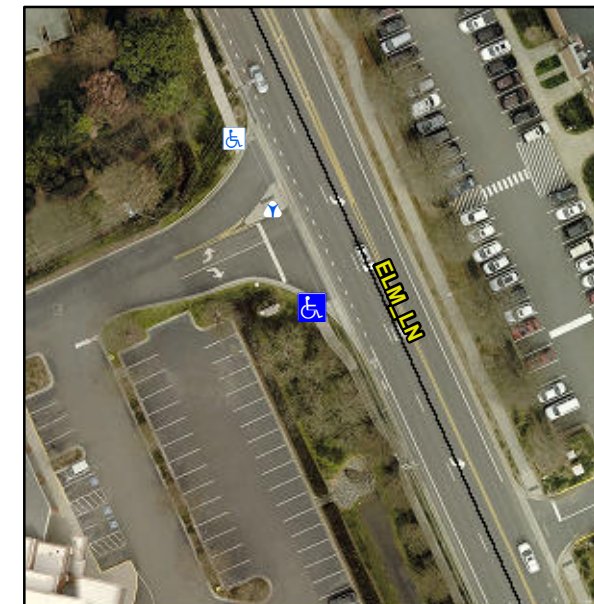
Compliance	Description	Data	Compliance	Description	Data
N/A	Ramp Length (in)	84.0	N/A	Grade Break?	N/A
Yes	Ramp Width (in)	69.5	N/A	Grade Break Slope (%)	0.0
Yes	Ramp Slope (%)	3.7	N/A	Grade Break XSlope (%)	0.0
No	Ramp XSlope (%)	4.6			
N/A	Flare Type LT	N/A	N/A	Flare Type RT	N/A
N/A	Flare Slope LT (%)	N/A	N/A	Flare Slope RT (%)	0.0
N/A	Flare Traversable LT?	N/A	N/A	Flare Traversable RT?	N/A
N/A	Landing Length (in)	0.0	N/A	DWS Provided?	N/A
N/A	Landing Width (in)	0.0	N/A	DWS Contrast?	N/A
N/A	Landing Slope (%)	0.0	N/A	DWS Length (in)	N/A
N/A	Landing X Slope (%)	0.0	N/A	DWS Full Width?	N/A
N/A	Landing Curb? (Y/N)	N/A	N/A	DWS Offset LT (in)	N/A
N/A	Shared Landing?	N/A	N/A	DWS Offset RT (in)	N/A
N/A	Gutter Ponding?	0.0	N/A	Gutter Slope (%)	N/A
N/A	Gutter Lip Ht (in)	0.0	N/A	Gutter X Slope (%)	N/A
N/A	Painted X Walk1?	No		Road Slope (%)	3.7
	X Walk 1 Direction	To N		Road X Slope (%)	7.1
	X Walk 1 Width (in)	N/A		Clear Space?	N/A

X Walk 1 Slope (%)	3.7	N/A	Clear Space to XWalk (in)	N/A
	X Walk 1 X Slope (%)	7.1	N/A	Storm Grate/Utility Hazard?	N/A
N/A	Ramp inside XWalk1?	N/A		Storm Grate/Utility Type	
N/A	Any Obstructions?	N/A			N/A
	Obstruction Type		Yes	Surface Condition? (G/P)	Good
			N/A	Curb Slope (%)	6.8

Possible Solutions:

**Remove & Replace Entire Ramp.**

**R304.5.3**
