Access Compliance Report

Public Rights-of-Way

(Curb Ramps)

Intersection ID: 13605	Main Street: CHARLOTTETOWNE_AV	Cross Street: E_5TH_ST	Location: E
ADA ID: 1EBA4D281393	Ramp Type: Perp	Initial Pass/Fail: Fail	Overall Compliance: No
Severity Score: 8.75			
Codes/Mitigation Info/Possible Solution		Field Measurements/Component Compliance

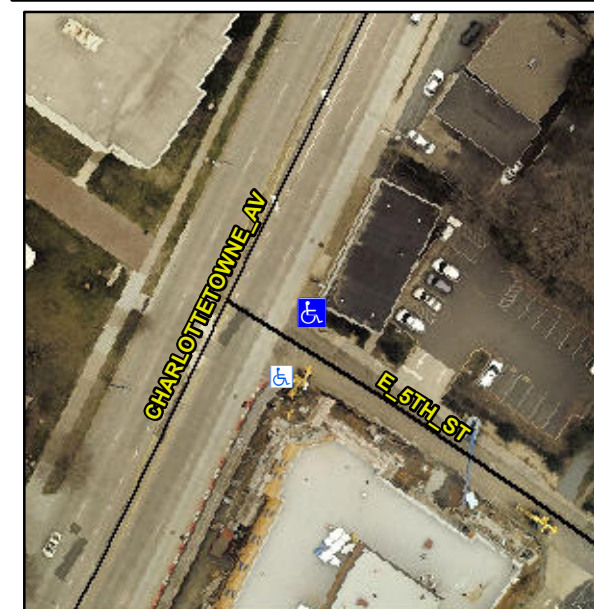
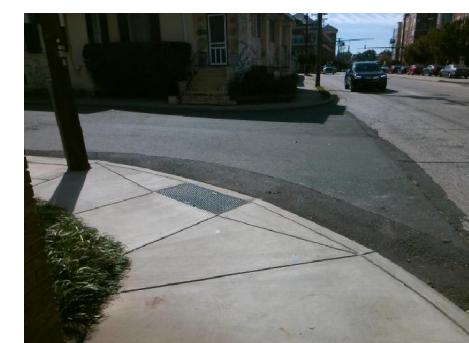
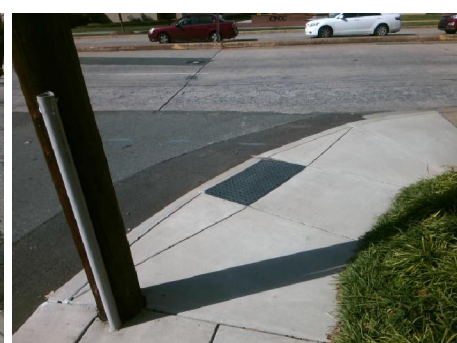
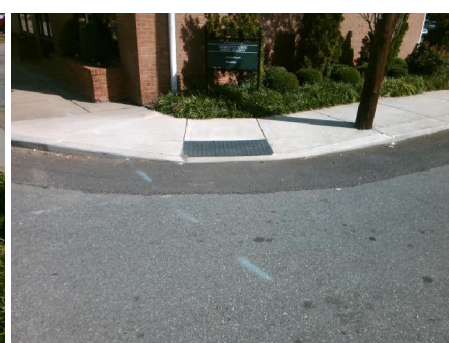
Compliance	Description	Data	Compliance	Description	Data
N/A	Ramp Length (in)	72.0	Yes	Ramp Slope (%)	6.3
No	Ramp Width (in)	46.5	Yes	Ramp XSlope (%)	1.9
N/A	Flare Type LT	N/A	N/A	Flare Type RT	N/A
N/A	Flare Slope LT (%)	N/A	N/A	Flare Slope RT (%)	N/A
N/A	Flare Traversable LT?	N/A	N/A	Flare Traversable RT?	N/A
N/A	Landing Length (in)	N/A	N/A	DWS Provided?	N/A
N/A	Landing Width (in)	N/A	N/A	DWS Contrast?	N/A
N/A	Landing Slope (%)	N/A	N/A	DWS Length (in)	N/A
N/A	Landing X Slope (%)	N/A	N/A	DWS Full Width?	N/A
N/A	Landing Curb? (Y/N)	N/A	N/A	DWS Offset (in)	N/A
N/A	Shared Landing?	N/A			
N/A	Gutter Ponding?	N/A	N/A	Gutter Slope (%)	N/A
N/A	Gutter Lip Ht (in)	N/A	N/A	Gutter X Slope (%)	N/A
N/A	Painted X Walk1?	No	N/A	Painted X Walk2?	N/A
	X Walk 1 Direction	To SW		X Walk 2 Direction	N/A
N/A	X Walk 1 Width (in)	N/A	N/A	X Walk 2 Width (in)	N/A
	X Walk 1 Slope (%)	2.9		X Walk 2 Slope (%)	N/A
	X Walk 1 X Slope (%)	1.4		X Walk 2 X Slope (%)	N/A

N/A	Ramp inside XWalk1?	N/A	N/A	Ramp inside XWalk2?	N/A
	Road Slope (%)	N/A	N/A	Clear Space?	N/A
	Road X Slope (%)	N/A	N/A	Clear Space to XWalk (in)	N/A
N/A	Any Obstructions?	N/A	N/A	Storm Grate/Utility Hazard?	N/A
	Obstruction Type			Storm Grate/Utility Type	
		N/A			N/A
			Yes	Surface Condition? (G/P)	Good

Remove & Replace Entire Ramp.

R304.5.1

\$ 1850.00
