Access Compliance Report

Public Rights-of-Way

(Curb Ramps)

Intersection ID: 11980	Main Street: ALLEN_ST	Cross Street: E_17TH_ST	Location: W
ADA ID: 1EC788B62521	Ramp Type: Directional1	Initial Pass/Fail: Pass	Overall Compliance: No
Codes/Mitigation Info/Possible Solution		Field Measurements/Component Compliance	
Severity Score: 10

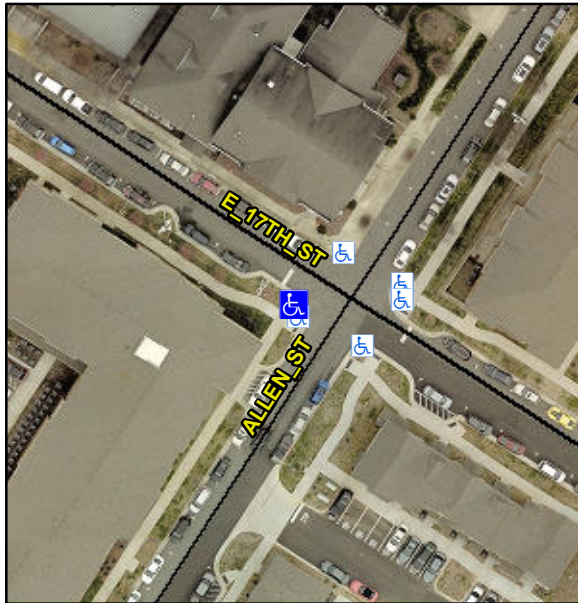
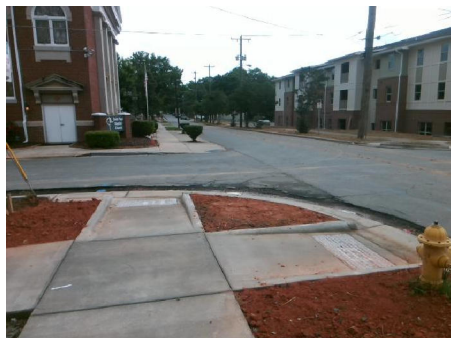
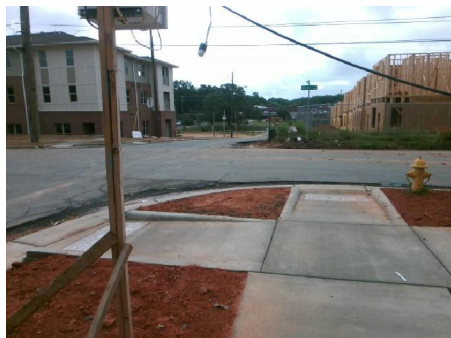
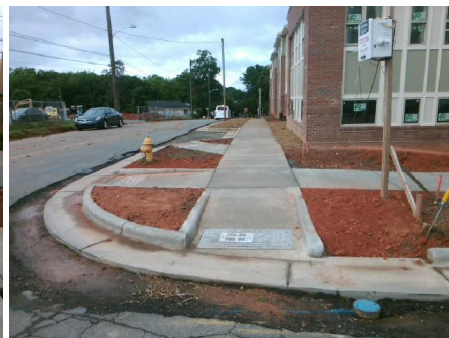
Compliance	Description	Data	Compliance	Description	Data
N/A	Ramp Length (in)	102.0	Yes	Grade Break?	Yes
Yes	Ramp Width (in)	56.0	Yes	Grade Break Slope (%)	4.1
Yes	Ramp Slope (%)	4.7	Yes	Grade Break XSlope (%)	1.7
Yes	Ramp XSlope (%)	0.6			
Yes	Flare Type LT	N/A	Yes	Flare Type RT	N/A
N/A	Flare Slope LT (%)	N/A	N/A	Flare Slope RT (%)	N/A
N/A	Flare Traversable LT?	No	N/A	Flare Traversable RT?	No
Yes	Landing Length (in)	72.0	Yes	DWS Provided?	Yes
Yes	Landing Width (in)	71.0	Yes	DWS Contrast?	Yes
Yes	Landing Slope (%)	0.9	Yes	DWS Length (in)	24.0
Yes	Landing X Slope (%)	1.4	No	DWS Full Width?	No
N/A	Landing Curb? (Y/N)	No	No	DWS Offset LT (in)	4.5
N/A	Shared Landing?	No	Yes	DWS Offset RT (in)	11.0
Yes	Gutter Ponding?	No	Yes	Gutter Slope (%)	3.8
No	Gutter Lip Ht (in)	0.3	Yes	Gutter X Slope (%)	0.4
N/A	Painted X Walk1?	No		Road Slope (%)	0.7
	X Walk 1 Direction	To NE		Road X Slope (%)	2.2
	X Walk 1 Width (in)	N/A		Clear Space?	Yes

X Walk 1 Slope (%)	0.7	N/A	Clear Space to XWalk (in)	N/A
	X Walk 1 X Slope (%)	2.2	Yes	Storm Grate/Utility Hazard?	No
N/A	Ramp inside XWalk1?	N/A		Storm Grate/Utility Type	
Yes	Any Obstructions?	No			N/A
	Obstruction Type		Yes	Surface Condition? (G/P)	Good
			N/A	Curb Slope (%)	4.7

Remove & Replace Detectable Warning System. Grind Gutter Lip.

R305.1.4, R305.2, R302.7.2
