Access Compliance Report

Public Rights-of-Way

(Curb Ramps)

Intersection ID: 9589	Main Street: FLOWERS_CT	Cross Street: WOODHILL_MANOR_CT	Location: SE
ADA ID: 1EC8CA3F1280	Ramp Type: Perp	Initial Pass/Fail: Fail	Overall Compliance: No
Severity Score: 8.75			
Codes/Mitigation Info/Possible Solution		Field Measurements/Component Compliance

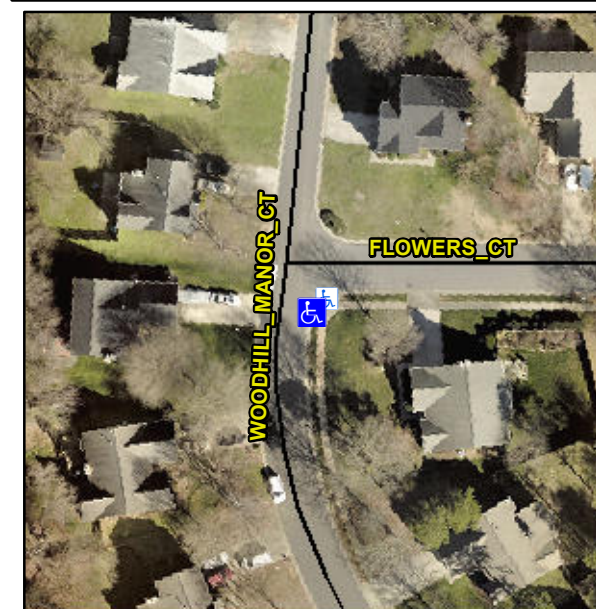
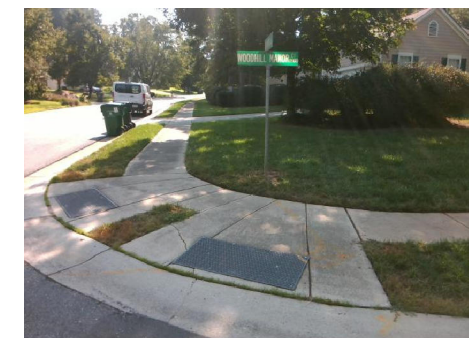
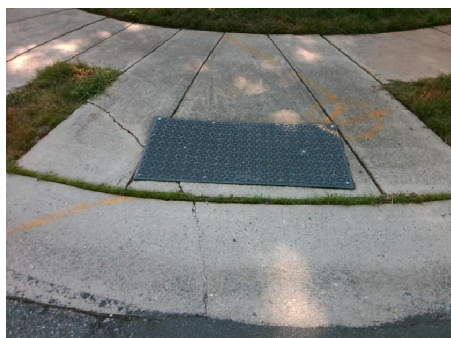
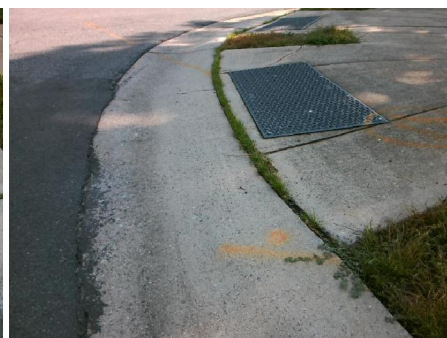
Not Found, R304.5.1

Compliance	Description	Data	Compliance	Description	Data
N/A	Ramp Length (in)	49.5	Yes	Ramp Slope (%)	7.2
No	Ramp Width (in)	36.5	Yes	Ramp XSlope (%)	2.0
N/A	Flare Type LT	N/A	N/A	Flare Type RT	N/A
N/A	Flare Slope LT (%)	N/A	N/A	Flare Slope RT (%)	N/A
N/A	Flare Traversable LT?	N/A	N/A	Flare Traversable RT?	N/A
N/A	Landing Length (in)	N/A	N/A	DWS Provided?	N/A
N/A	Landing Width (in)	N/A	N/A	DWS Contrast?	N/A
N/A	Landing Slope (%)	N/A	N/A	DWS Length (in)	N/A
N/A	Landing X Slope (%)	N/A	N/A	DWS Full Width?	N/A
N/A	Landing Curb? (Y/N)	N/A	N/A	DWS Offset (in)	N/A
N/A	Shared Landing?	N/A			
N/A	Gutter Ponding?	N/A	N/A	Gutter Slope (%)	N/A
N/A	Gutter Lip Ht (in)	N/A	N/A	Gutter X Slope (%)	N/A
N/A	Painted X Walk1?	No	N/A	Painted X Walk2?	N/A
	X Walk 1 Direction	To W		X Walk 2 Direction	N/A
N/A	X Walk 1 Width (in)	N/A	N/A	X Walk 2 Width (in)	N/A
	X Walk 1 Slope (%)	2.8		X Walk 2 Slope (%)	N/A
	X Walk 1 X Slope (%)	0.1		X Walk 2 X Slope (%)	N/A

N/A	Ramp inside XWalk1?	N/A	N/A	Ramp inside XWalk2?	N/A
	Road Slope (%)	N/A	N/A	Clear Space?	N/A
	Road X Slope (%)	N/A	N/A	Clear Space to XWalk (in)	N/A
N/A	Any Obstructions?	N/A	N/A	Storm Grate/Utility Hazard?	N/A
	Obstruction Type			Storm Grate/Utility Type	
		N/A			N/A
			Yes	Surface Condition? (G/P)	Good

Remove & Replace Entire Ramp.

Total Cost: \$ 1850.00
