Access Compliance Report

Public Rights-of-Way

(Curb Ramps)

Intersection ID: 16132	Main Street: S_TRYON_ST	Cross Street: W_CAMA_ST	Location: NW
ADA ID: 1ECAF07F2369	Ramp Type: PerpDiag	Initial Pass/Fail: Fail	Overall Compliance: No
		Severity Score: 10

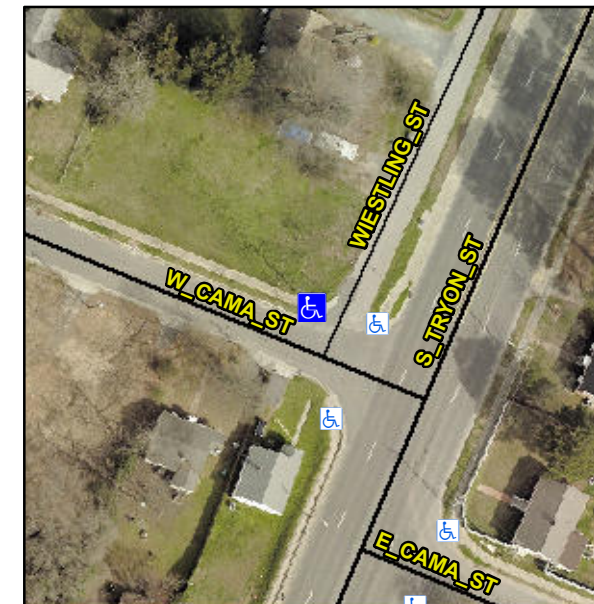
Not Found, R304.5.1, R304.5.3

Compliance	Description	Data	Compliance	Description	Data
N/A	Ramp Length (in)	45.0	Yes	Ramp Slope (%)	7.6
No	Ramp Width (in)	43.0	No	Ramp XSlope (%)	4.5
N/A	Flare Type LT	N/A	N/A	Flare Type RT	N/A
N/A	Flare Slope LT (%)	N/A	N/A	Flare Slope RT (%)	N/A
N/A	Flare Traversable LT?	N/A	N/A	Flare Traversable RT?	N/A
N/A	Landing Length (in)	N/A	N/A	DWS Provided?	N/A
N/A	Landing Width (in)	N/A	N/A	DWS Contrast?	N/A
N/A	Landing Slope (%)	N/A	N/A	DWS Length (in)	N/A
N/A	Landing X Slope (%)	N/A	N/A	DWS Full Width?	N/A
N/A	Landing Curb? (Y/N)	N/A	N/A	DWS Offset (in)	N/A
N/A	Shared Landing?	N/A			
N/A	Gutter Ponding?	N/A	N/A	Gutter Slope (%)	N/A
N/A	Gutter Lip Ht (in)	N/A	N/A	Gutter X Slope (%)	N/A
N/A	Painted X Walk1?	No	N/A	Painted X Walk2?	No
	X Walk 1 Direction	To S		X Walk 2 Direction	To SE
N/A	X Walk 1 Width (in)	N/A	N/A	X Walk 2 Width (in)	N/A
	X Walk 1 Slope (%)	2.4		X Walk 2 Slope (%)	2.2
	X Walk 1 X Slope (%)	2.2		X Walk 2 X Slope (%)	5.8

N/A	Ramp inside XWalk1?	N/A	N/A	Ramp inside XWalk2?	N/A
	Road Slope (%)	5.0	N/A	Clear Space?	N/A
	Road X Slope (%)	2.8	N/A	Clear Space to XWalk (in)	N/A
N/A	Any Obstructions?	N/A	N/A	Storm Grate/Utility Hazard?	N/A
	Obstruction Type			Storm Grate/Utility Type	
		N/A			N/A
		Yes		Surface Condition? (G/P)	Good

Remove & Replace Curb Ramp With Two New Directional Ramps or Equivalent.
