Access Compliance Report

Public Rights-of-Way

(Curb Ramps)

Intersection ID: N/A	Main Street: PAISLEY_ABBEY_LN	Cross Street: KELBURN_LN	Location: SW
ADA ID: 1ED88B2A894C	Ramp Type: Perp	Initial Pass/Fail: Fail	Overall Compliance: No
Codes/Mitigation Info/Possible Solution		Field Measurements/Component Compliance	
Severity Score: 10

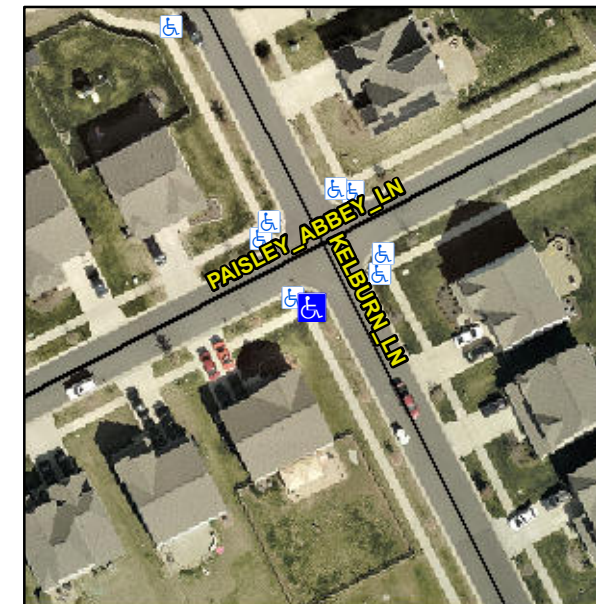
PROW/ADA:

Not Found, R304.5.1, R304.5.3

Compliance	Description	Data	Compliance	Description	Data
N/A	Ramp Length (in)	104.0	Yes	Ramp Slope (%)	7.8
No	Ramp Width (in)	41.0	No	Ramp XSlope (%)	2.6
N/A	Flare Type LT	N/A	N/A	Flare Type RT	N/A
N/A	Flare Slope LT (%)	N/A	N/A	Flare Slope RT (%)	N/A
N/A	Flare Traversable LT?	N/A	N/A	Flare Traversable RT?	N/A
N/A	Landing Length (in)	N/A	N/A	DWS Provided?	N/A
N/A	Landing Width (in)	N/A	N/A	DWS Contrast?	N/A
N/A	Landing Slope (%)	N/A	N/A	DWS Length (in)	N/A
N/A	Landing X Slope (%)	N/A	N/A	DWS Full Width?	N/A
N/A	Landing Curb? (Y/N)	N/A	N/A	DWS Offset (in)	N/A
N/A	Shared Landing?	N/A			
N/A	Gutter Ponding?	N/A	N/A	Gutter Slope (%)	N/A
N/A	Gutter Lip Ht (in)	N/A	N/A	Gutter X Slope (%)	N/A
N/A	Painted X Walk1?	No	N/A	Painted X Walk2?	N/A
	X Walk 1 Direction	To NE		X Walk 2 Direction	N/A
N/A	X Walk 1 Width (in)	N/A	N/A	X Walk 2 Width (in)	N/A
	X Walk 1 Slope (%)	0.4		X Walk 2 Slope (%)	N/A
	X Walk 1 X Slope (%)	3.4		X Walk 2 X Slope (%)	N/A

N/A	Ramp inside XWalk1?	N/A	N/A	Ramp inside XWalk2?	N/A
	Road Slope (%)	N/A	N/A	Clear Space?	N/A
	Road X Slope (%)	N/A	N/A	Clear Space to XWalk (in)	N/A
N/A	Any Obstructions?	N/A	N/A	Storm Grate/Utility Hazard?	N/A
	Obstruction Type			Storm Grate/Utility Type	
		N/A			N/A
			Yes	Surface Condition? (G/P)	Good

Possible Solutions:

Remove & Replace Entire Ramp.
