Access Compliance Report

Public Rights-of-Way (Curb Ramps)

Intersection ID: 5714	Main Street: JOHN_KIRK_DR	Cross Street: UNIVERSITY_CITY_BV	Location:	W
ADA ID: 1ED970B0581F	Ramp Type: Directional1	Initial Pass/Fail: Pass	Overall Compliance: No	Severity Score: 10

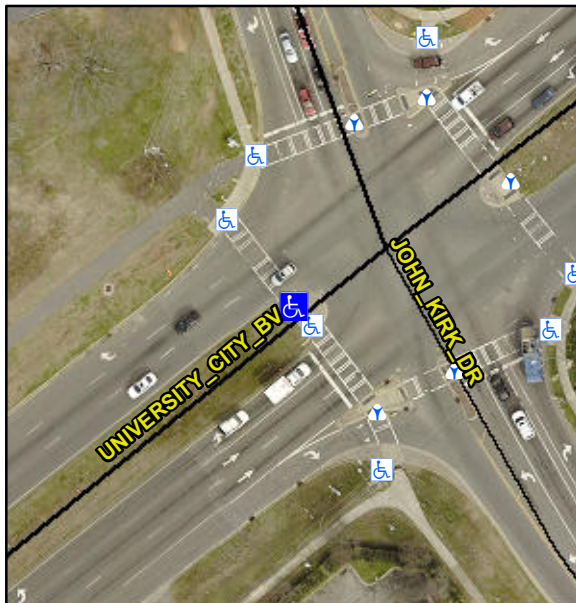
RP < 5%

Compliance	Description	Data	Compliance	Description	Data
N/A	Ramp Length (in)	36.0	N/A	Grade Break?	N/A
Yes	Ramp Width (in)	96.0	N/A	Grade Break Slope (%)	0.0
Yes	Ramp Slope (%)	3.1	N/A	Grade Break XSlope (%)	0.0
Yes	Ramp XSlope (%)	0.4			
No	Flare Type LT	N/A	Yes	Flare Type RT	N/A
N/A	Flare Slope LT (%)	N/A	N/A	Flare Slope RT (%)	N/A
N/A	Flare Traversable LT?	No	N/A	Flare Traversable RT?	No
Yes	Landing Length (in)	69.0	Yes	DWS Provided?	Yes
Yes	Landing Width (in)	96.0	Yes	DWS Contrast?	Yes
Yes	Landing Slope (%)	1.6	Yes	DWS Length (in)	25.0
Yes	Landing X Slope (%)	0.5	Yes	DWS Full Width?	Yes
N/A	Landing Curb? (Y/N)	No	No	DWS Offset LT (in)	10.0
N/A	Shared Landing?	Yes	Yes	DWS Offset RT (in)	30.0
No	Gutter Ponding?	Yes	No	Gutter Slope (%)	7.0
Yes	Gutter Lip Ht (in)	0.0	No	Gutter X Slope (%)	2.4
N/A	Painted X Walk1?	Yes		Road Slope (%)	0.4
	X Walk 1 Direction	To NW		Road X Slope (%)	0.7
	X Walk 1 Width (in)	108.0		Clear Space?	Yes

X Walk 1 Slope (%)	0.4	N/A	Clear Space to XWalk (in)	N/A
	X Walk 1 X Slope (%)	0.7	Yes	Storm Grate/Utility Hazard?	No
Yes	Ramp inside XWalk1?	Yes		Storm Grate/Utility Type	
Yes	Any Obstructions?	No			N/A
	Obstruction Type		Yes	Surface Condition? (G/P)	Good
			N/A	Curb Slope (%)	5.2

**Remove & Replace Entire Ramp.
Remove & Replace Gutter.**

**R304.2.3, R305.2, R302.7, R304.5.4,
R304.5.3**
